Proceedings of the 11th MONUBASIN (2024)

Restoration Study of late Ottoman Terzakis House in Nafplion

Georgios P. Antoniou

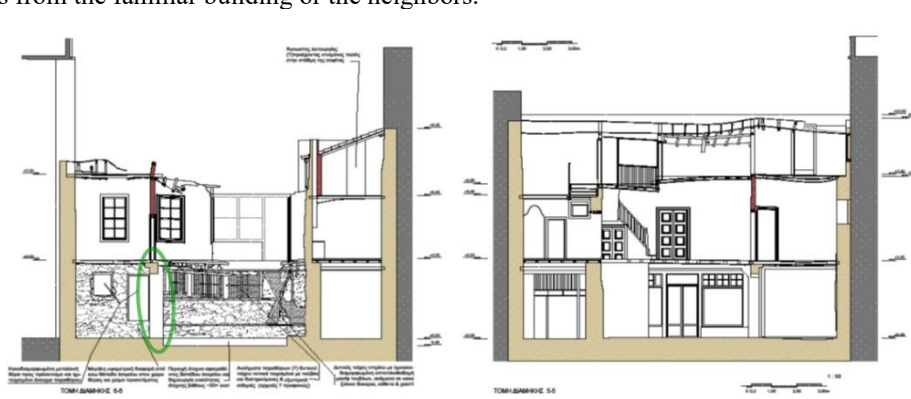
Fig 2. Longitudinal Sections of Terzaki, showing Ground floor, 1st floor, and Attic floor (B) (the green ellipse, on where the newer reinforced concrete beam and pillars had been put)

The North-South internal wall to the south now has newer (pre-war or immediately post-war) concrete beams with a connection insert that apparently replaced an original load-bearing wall there. Support of the newer concrete beams apparently replaced most of the stone-built (?) wall there.

Underneath the newest beton beams, additional wall thicknesses are planned with elements of plaster-board walls, 15 cm thick, with an internal galvanized metal frame. Between them, 22 million of space for storage, leaving access openings in the ground floor exhibition. Also, IT facilities for the future configuration of visitor entry control.

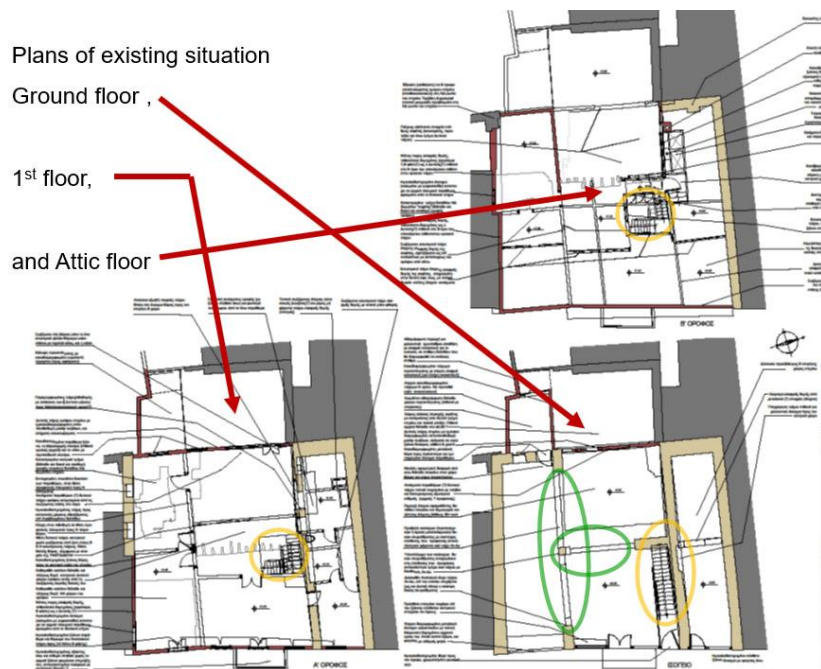
Fig 5 Plans of existing situation Ground floor , 1st floor, and Attic floor

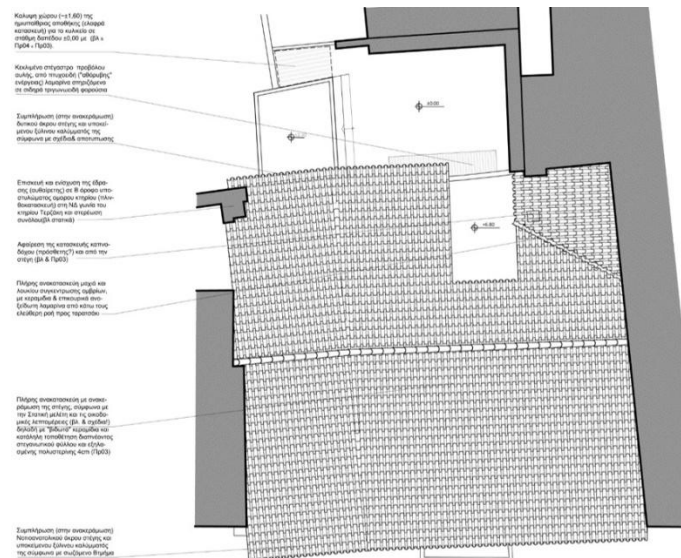
Fig 7. A full reconstruction with retiling of the roof planned, according to the Static study and the construction details i.e. with "screwed" tiles and proper placement of a breathable waterproofing sheet and 4cm extruded polystyrene

A full reconstruction with retiling of the roof is planned, according to 7 of the Static study and the construction details (see & plans!) i.e. with "screwed" tiles and proper placement of a breathable waterproofing sheet and 4cm extruded polystyrene (P03 and P06)

Completion (in the brickwork) of the western edge of the roof and its underlying wooden covering according to drawings & impressions.

Completion (in the brickwork) of the Southeast end of the roof and its underlying wooden covering according to the preserved Northern part.
