Restoration Study of late Ottoman Terzakis House in Nafplion

Georgios P. Antoniou, Buildings restorer MSc UoYork UK, PhD candidate NTUA, Athens, Greece
antonioug@tee.gr

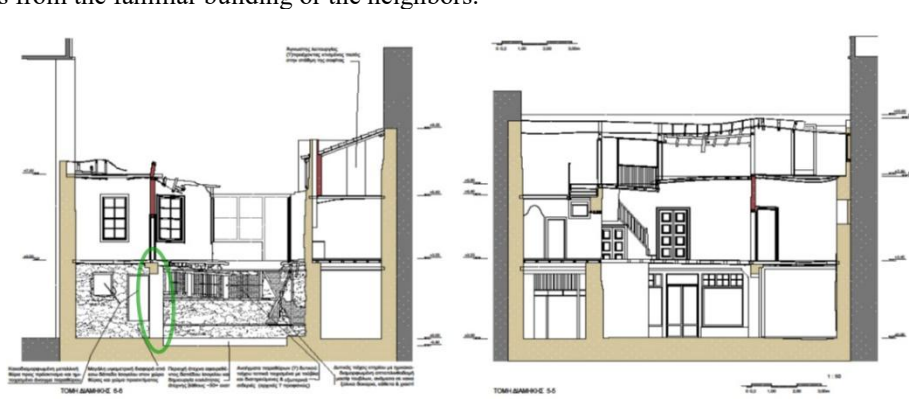
Fig 2. Longitudinal Sections of Terzaki, showing Ground floor, 1st floor, and Attic floor (B) (the green ellipse, on where the newer reinforced concrete beam and pillars had been put)

The North-South internal wall to the south now has newer (pre-war or immediately post-war) concrete beams with a connection insert that apparently replaced an original load-bearing wall there. Support of the newer concrete beams apparently replaced most of the stone-built (?) wall there.

Underneath the newest beton beams, additional wall thicknesses are planned with elements of plaster-board walls, 15 cm thick, with an internal galvanized metal frame. Between them, 22 million of space for storage, leaving access openings in the ground floor exhibition. Also, IT facilities for the future configuration of visitor entry control.

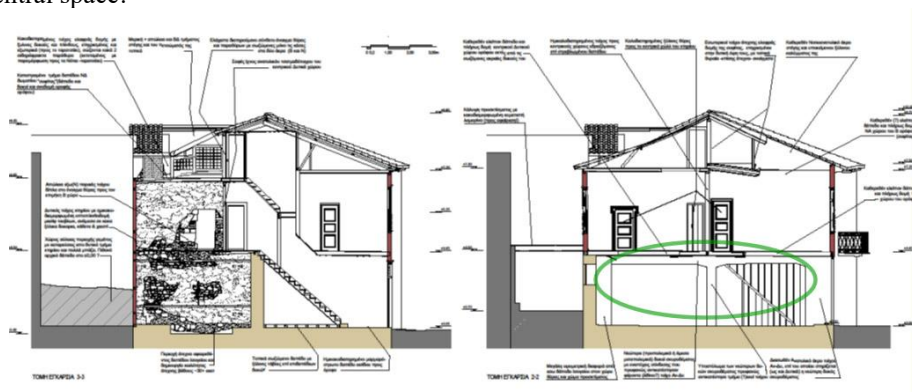
Fig 3 Transverse Sections of Terzaki, showing Ground floor, 1st floor, and Attic floor (**B**) (the green ellipse, on where the newer reinforced concrete beam and pillars had been put, to expand ! ground floor shops area !!!)

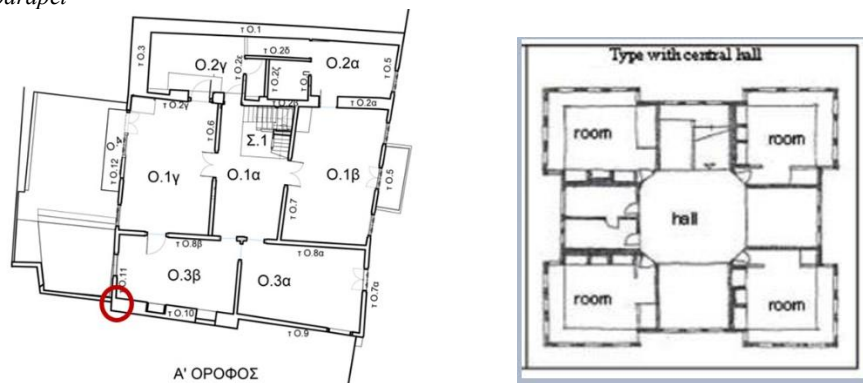
The placement (arbitrarily!) on the B floor (attic) of a single building column (brick construction) in the SW corner of the Terzakis building creates great static cracking problems in the SW corner of the building!

Fig. 6a Repair -reinforcement in SW corner (red cycle) in all floors due to the (arbitrary) placement of a pillar of a neighbor building! **6b** The formation of the 1st floor proves the relation with Ottoman similar layouts.

Most important element!! Repair and reinforcement in the SW corner of the Terzakis building due to its (arbitrary) location on the second floor of a pillar of a neighboring building!

Most important element!! Repair and reinforcement in the SW corner of the Terzakis building due to the (arbitrary) placement of a pillar of a similar building here!
