HNPS Advances in Nuclear Physics

X. A. Aslanoglou, E. Evangelou, N. Konofaos, Ch. Dimitriades, E. Kossionides, G. Kaliampakos, G. Kriembardis

Oxygen Contamination of Multilayer $TiN_x - SiO_2 - Si$ Structures found by Resonant RBS Analysis

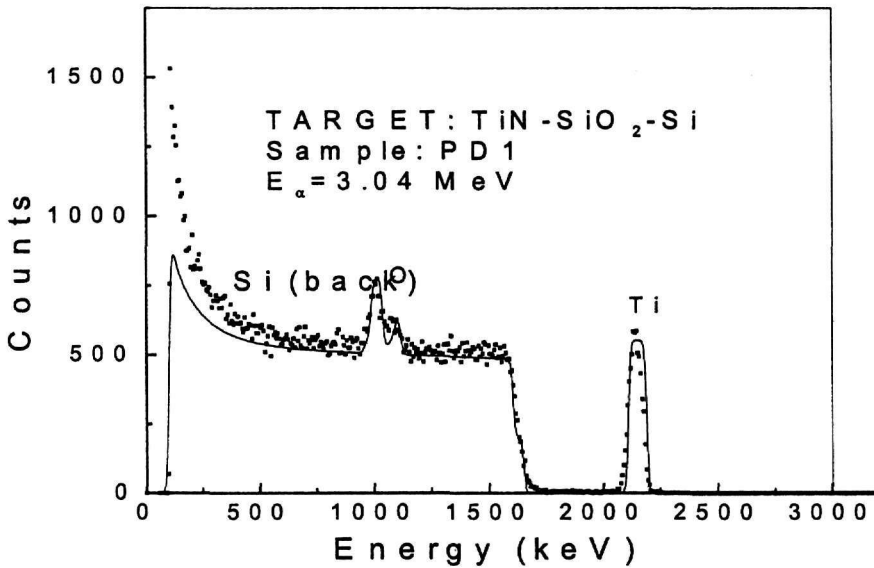
Fig. 2. Spectrum of the sample PD1 at energy $E = 3.04\text{MeV}$. The solid line represents simulation to the experimental spectrum.

Figure 2 shows the experimental spectrum of the sample PD1, which is again characterized by good electrical behavior, together with the simulation (solid line). The simulation reproduces the experimental spectrum in a good way, under the assumption that the surface density of the TiN layer is $42\mu\text{g}/\text{cm}^2$ and the thickness of the SiO_2 layer is $22\mu\text{g}/\text{cm}^2$. The Oxygen contamination of the surface of the TiN film was determined at 7%. Contamination levels as high as 15% were found in other samples, which are characterized by poor electrical behavior.
