# Oxygen Contamination of Multilayer $TiN_x - SiO_2 - Si$ Structures found by Resonant RBS Analysis

## Abstract

Multi layer structures consisting of  $TiN - SiO_2 - Si$  layers operating as MOS devices were constructed and tested for their electrical properties. RBS and resonance reaction analysis were performed for the characterisation of the structure of the devices. The results show a correlation between the structure found by RBS and the electrical performance of the devices.

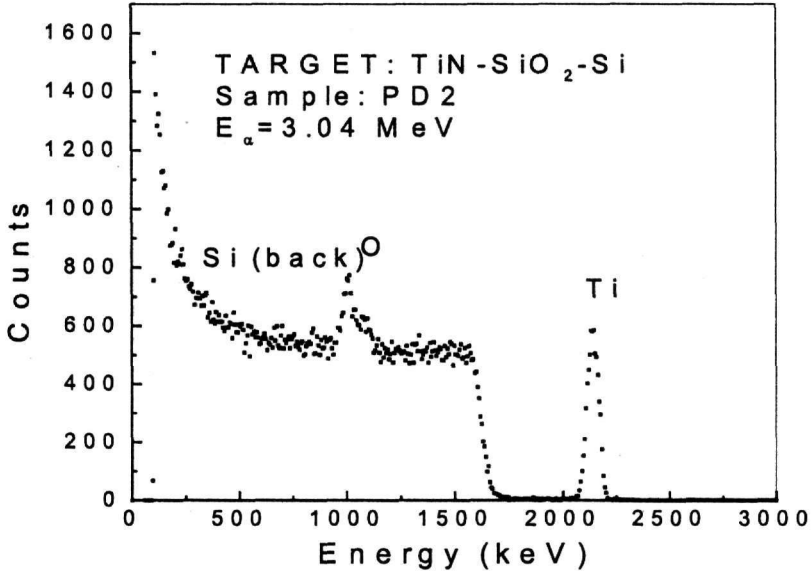
Fig. 1. Experimental spectrum of a  $TiN - SiO_2 - Si$  structure at energy  $E = 3.04 MeV$ .

At energy  $E = 3.04 MeV$ , the  $\alpha + ^{16}O$  resonance is at the surface of the TiN film and therefore can provide information about the Oxygen contamination of the surface. A spectrum of the diode PD2, which is characterized by good electrical behavior, is presented in fig. 1. Since the energy of the beam is high and the thickness of the films is small (of the order of  $1000 \text{ \AA}$ ), the energy deposited by the  $\alpha$ -particles in the target is low as compared to the energy resolution of the detector. This leads to a poor depth resolution of the experiment.

The Titanium plateau from Rutherford Scattering is clear at the end of the spectrum. The "shoulder" of Silicon contained the  $SiO_2$  film is comparable

to the depth resolution of the experiment and can barely be seen. There are two Oxygen peaks though sticking out of the Si backing continuum. The low energy one corresponds to the Oxygen contained in the  $\text{SiO}_2$  layer and the high energy one corresponds to the Oxygen contamination of the TiN film. All samples were found to be contaminated by Oxygen, at a different level. The Nitrogen plateau is not seen, because it is very small and interferes with the O plateaus.

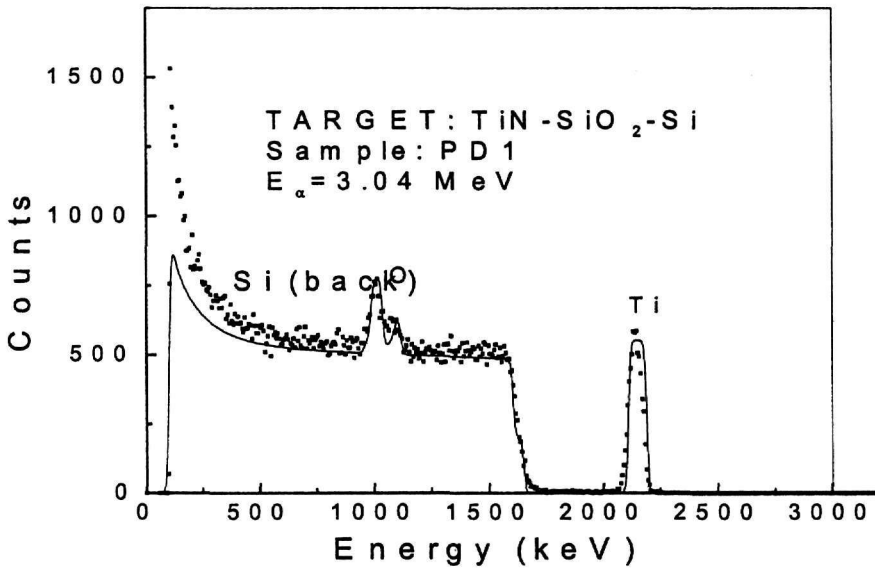
Fig. 2. Spectrum of the sample PD1 at energy  $E = 3.04\text{MeV}$ . The solid line represents simulation to the experimental spectrum.

Figure 2 shows the experimental spectrum of the sample PD1, which is again characterized by good electrical behavior, together with the simulation (solid line). The simulation reproduces the experimental spectrum in a good way, under the assumption that the surface density of the TiN layer is  $42\mu\text{g}/\text{cm}^2$  and the thickness of the  $\text{SiO}_2$  layer is  $22\mu\text{g}/\text{cm}^2$ . The Oxygen contamination of the surface of the TiN film was determined at 7%. Contamination levels as high as 15% were found in other samples, which are characterized by poor electrical behavior.

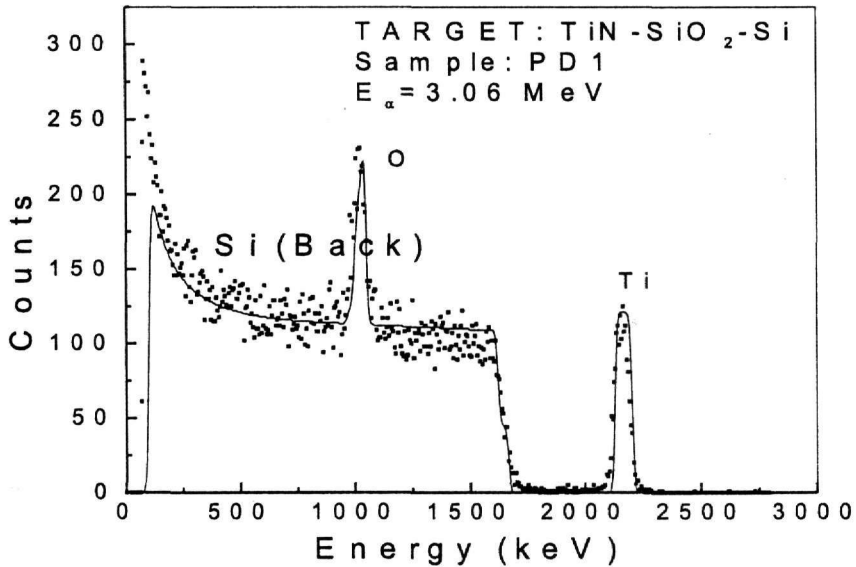
Fig. 3. Spectrum of the sample PD1 at energy  $E = 3.06\text{MeV}$ . The solid line represents simulation to the experimental spectrum. The data show no Oxygen contamination at the backside of the sample.

In a second experiment the energy of the beam was increased to  $E = 3.06\text{MeV}$ , thus placing the resonance at a depth of  $25\mu\text{g}/\text{cm}^2$  inside the TiN film, thus investigating the backside of the layer. The experimental spectrum of the sample PD1 is shown in fig. 3. Only one Oxygen peak exists, corresponding the Oxygen contained in the  $\text{SiO}_2$  layer and is well reproduced by the simulation under this assumption.
