## HNPS Advances in Nuclear Physics

Vol 10 (1999)

### Oxygen Contamination of Multilayer TiNx — SiO<sub>2</sub> — Si Structures found by Resonant RBS Analysis

# Oxygen Contamination of Multilayer $TiN_x - SiO_2 - Si$ Structures found by Resonant RBS Analysis

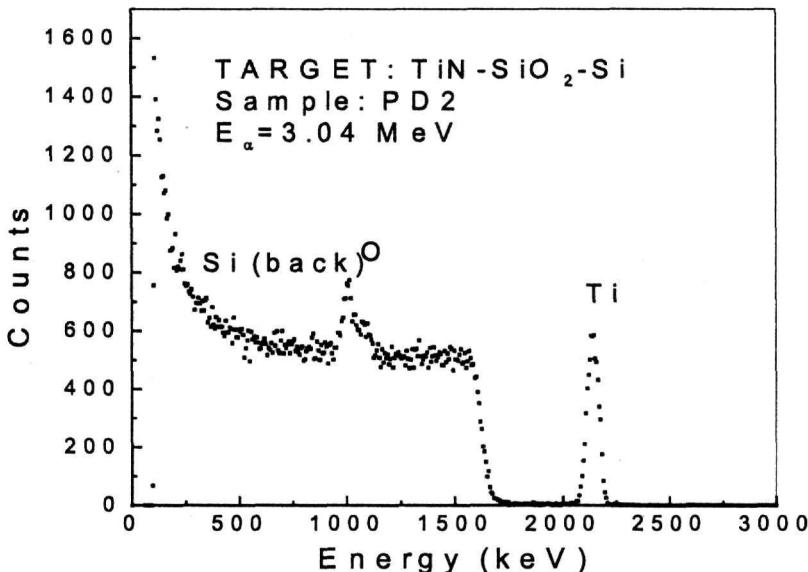
Fig. 1. Experimental spectrum of a  $TiN - SiO_2 - Si$  structure at energy  $E = 3.04 MeV$ .

At energy  $E = 3.04 MeV$ , the  $\alpha + {}^{16}O$  resonance is at the surface of the  $TiN$  film and therefore can provide information about the Oxygen contamination of the surface. A spectrum of the diode PD2, which is characterized by good electrical behavior, is presented in fig. 1. Since the energy of the beam is high and the thickness of the films is small (of the order of  $1000\text{\AA}$ ), the energy deposited by the  $\alpha$ -particles in the target is low as compared to the energy resolution of the detector. This leads to a poor depth resolution of the experiment.

The Titanium plateau from Rutherford Scattering is clear at the end of the spectrum. The "shoulder" of Silicon contained the  $SiO_2$  film is comparable

to the depth resolution of the experiment and can barely be seen. There are two Oxygen peaks though sticking out of the Si backing continuum. The low energy one corresponds to the Oxygen contained in the  $\text{SiO}_2$  layer and the high energy one corresponds to the Oxygen contamination of the TiN film. All samples were found to be contaminated by Oxygen, at a different level. The Nitrogen plateau is not seen, because it is very small and interferes with the O plateaus.

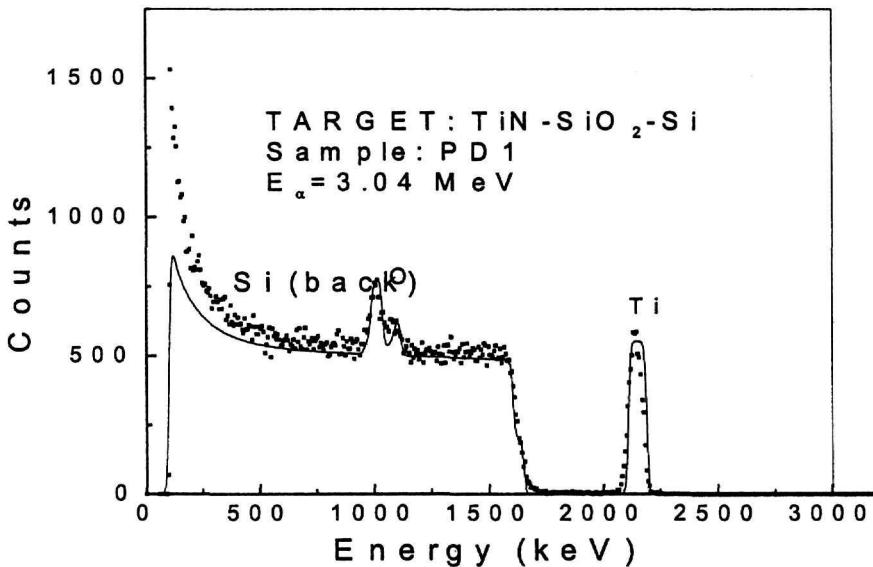
Fig. 2. Spectrum of the sample PD1 at energy  $E = 3.04\text{MeV}$ . The solid line represents simulation to the experimental spectrum.

For the analysis of the spectra we performed simulations of the experimental spectra using the code LEFI, developed at the University of Ioannina [5]. Rutherford scattering plus resonance cross sections for the system  $\alpha + {}^{16}\text{O}$  were engaged in the simulations.

Figure 2 shows the experimental spectrum of the sample PD1, which is again characterized by good electrical behavior, together with the simulation (solid line). The simulation reproduces the experimental spectrum in a good way, under the assumption that the surface density of the TiN layer is  $42\mu\text{g}/\text{cm}^2$  and the thickness of the  $\text{SiO}_2$  layer is  $22\mu\text{g}/\text{cm}^2$ . The Oxygen contamination of the surface of the TiN film was determined at 7%. Contamination levels as high as 15% were found in other samples, which are characterized by poor electrical behavior.

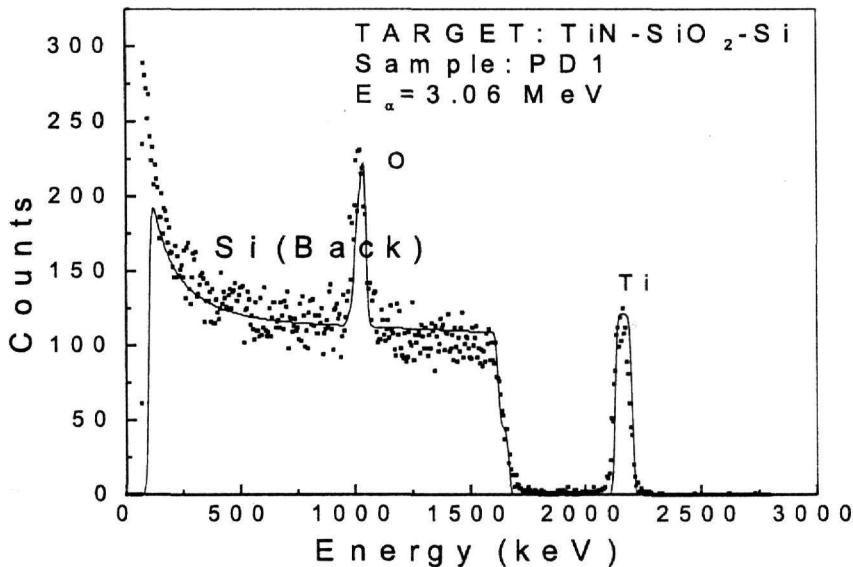
Fig. 3. Spectrum of the sample PD1 at energy  $E = 3.06\text{MeV}$ . The solid line represents simulation to the experimental spectrum. The data show no Oxygen contamination at the backside of the sample.

In a second experiment the energy of the beam was increased to  $E = 3.06\text{MeV}$ , thus placing the resonance at a depth of  $25\mu\text{g}/\text{cm}^2$  inside the TiN film, thus investigating the backside of the layer. The experimental spectrum of the sample PD1 is shown in fig. 3. Only one Oxygen peak exists, corresponding the Oxygen contained in the  $\text{SiO}_2$  layer and is well reproduced by the simulation under this assumption.
