Oxygen Contamination of Multilayer $TiN_x - SiO_2 - Si$ Structures found by Resonant RBS Analysis

Multi layer structures consisting of $TiN - SiO_2 - Si$ layers operating as MOS devices were constructed and tested for their electrical properties. RBS and resonance reaction analysis were performed for the characterisation of the structure of the devices. The results show a correlation between the structure found by RBS and the electrical performance of the devices.

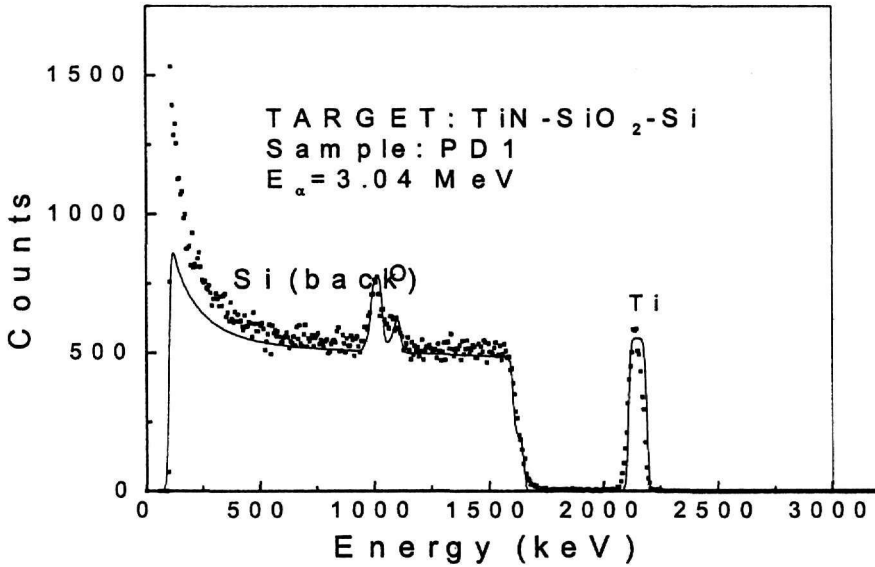
Fig. 2. Spectrum of the sample PD1 at energy $E = 3.04\text{MeV}$. The solid line represents simulation to the experimental spectrum.

Figure 2 shows the experimental spectrum of the sample PD1, which is again characterized by good electrical behavior, together with the simulation (solid line). The simulation reproduces the experimental spectrum in a good way, under the assumption that the surface density of the TiN layer is $42\mu\text{g}/\text{cm}^2$ and the thickness of the SiO_2 layer is $22\mu\text{g}/\text{cm}^2$. The Oxygen contamination of the surface of the TiN film was determined at 7%. Contamination levels as high as 15% were found in other samples, which are characterized by poor electrical behavior.
