Proceedings of the 11th MONUBASIN (2024)

Preliminary Restoration Proposal for the Holy Monastery of “Kokkini Ecclesia” (Red Church) in Lefkada

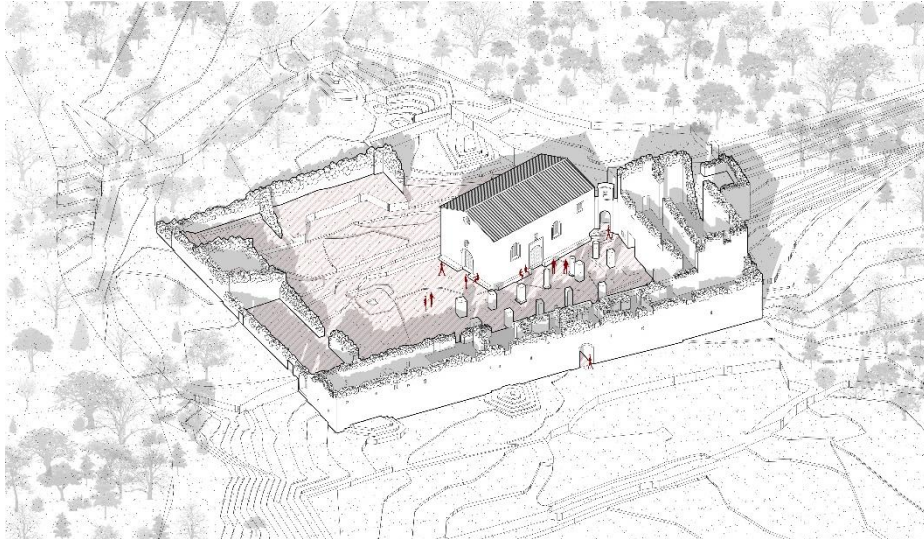
Fig. 4. Axonometric diagram of the existing Monastery.
