Proceedings of the 11th MONUBASIN (2024)

# Characterization of mortars from the Vartalis Watermill in Cyprus

**Abstract.** Traditional watermills for grain production are found in many places across the world. However, despite being an integral part of rural agriculture throughout history, these structures have received relatively little attention compared to other monuments and traditional buildings. Hence, studies of their building materials, including mortars, remain scarce. This paper focuses on the assessment of four mortar samples received from the Vartalis watermill in Cyprus. The study is part of a wider project focusing on the building materials (especially mortars) of a number of watermills around Nicosia and Cyprus. Two of the four mortar samples investigated were extracted from the aqueduct leading to the water tower, while the remaining two were obtained from the water tower of the watermill. In both cases, the mortars were in direct contact with water whilst the water tower was operative. Therefore, the assessment involved an insight into their consistency and hydraulic properties. Macroscopic observations and laboratory analytical experimental techniques, which inc

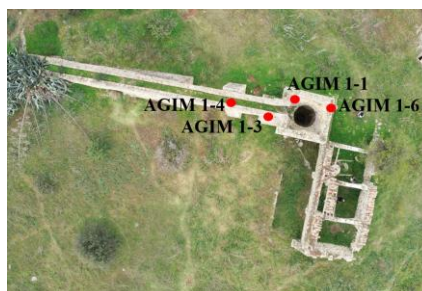
The mill (Fig. 2) is well preserved and retains the aqueduct, the water tower with its pit, the main room with the grinding mechanism, the underground room which housed the waterwheel, and traces of an auxiliary room. It is built of local limestones and river pebbles, while the interior surfaces of the aqueduct and the water tower are plastered.

**Fig. 2.** Aerial view of the Vartalis watermill, showing the sampling locations.

Four mortar samples were extracted from the preserved remains of the Vartalis watermill (see Fig. 2) using a hammer and chisel. Two of these samples are classified as jointing mortars and were extracted from the aqueduct (AGIM 1-3) and the water tower (AGIM 1-6), while the remaining two are classified as plasters and were collected from the interior of the walls of the aqueduct (AGIM 1-4) and the water tower (AGIM 1-1).

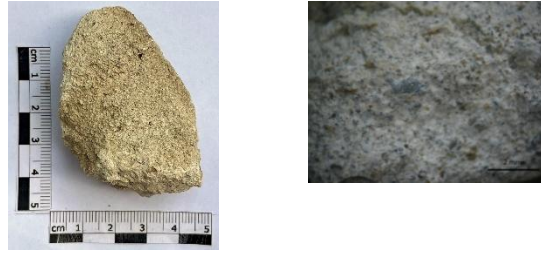
**Table 1.** Macroscopic and microscopic characteristics of the mortar samples collected from the Vartalis watermill.

Sample	Sampling location	Photo (in hand)	Photo (stereomicroscope)
AGIM 1-1	Water tower – Plaster

AGIM 1-3	Aqueduct – Plaster

AGIM 1-4	Aqueduct – Plaster

Water tower -  
AGIM 1-6 Jointing mortar

Preliminary macroscopic observations of the bulk specimens showed that all four samples were made of the same type of raw materials (see Table 1). Most of the samples appeared to be light grey or grey in color. The mortars extracted from the water tower were harder and more compact compared to those extracted from the aqueduct. The two mortars extracted from the interior walls of the aqueduct and the water tower were characterized by smooth external surfaces. None of the samples showed evidence of the presence of layers; all samples could be described as homogenous.

Further observations under the stereomicroscope revealed that the mortar samples were consistent with densely packed river sand as aggregate material; the latter ranged from ca. 0.2 to 2 mm in grain size and comprised various colors and shapes (see Table 1). In all samples, mainly subangular to rounded aggregate particles with grey and dark brown colors were identified, while the color of the binder was mostly whitish, suggesting a calcitic origin. Moreover, within the binder matrix of some samples, lime lumps measuring up to 2 mm were observed (see Table 1), the presence of which is common in historic lime mortars, indicating an incomplete calcination process [3]. It is noteworthy that lime lumps were identified only in the samples extracted from the water tower of the mill (AGIM 1-1 and AGIM 1-6). Sample AGIM 1-1 further showed evidence of the presence of some subangular and extremely fine reddish clay inclusions with grains < 1 mm. In sample AGIM 1-3, traces of coal were observed.
