Proceedings of the 11th MONUBASIN (2024)

Rope access monitoring and data management of the monumental complex in Piazza dei Miracoli in Pisa

Keywords: Rope access monitoring, Periodical maintenance planning, Piazza dei Miracoli.

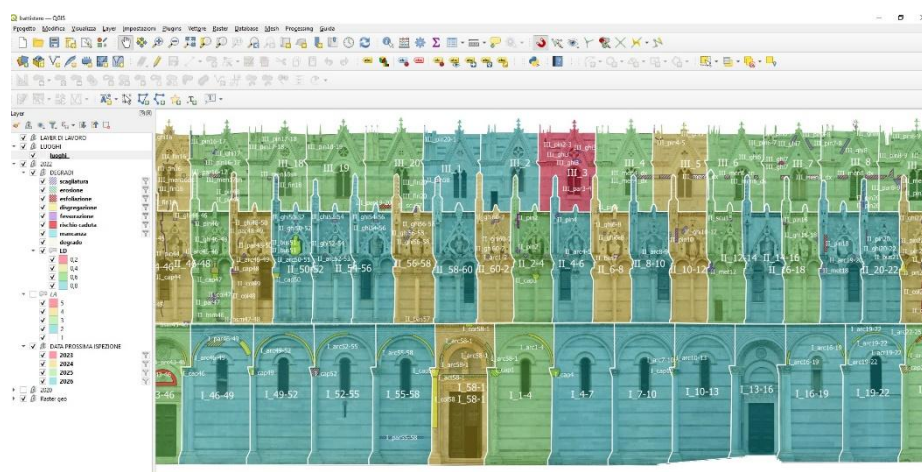
Fig. 4 GIS data management of Baptistery data.

The data collected are organized in a GIS (Geographic Information System), which allows identifying the component's location. The peculiarity of the GIS system is to integrate the representation of metric data with the alphanumeric information that characterizes the heritage from a conservation point of view. GIS stores, manages, and visualizes data with spatial identification and links the graphic representation with the informative data in a virtual folder [4]. So, the information about the single monument such as scientific analysis, photos, inspection sheets, documentation of the condition, and restoration work, could be collected in a virtual folder and consultable by all OPA technicians.

The GIS system geo-references data showing the survey geometries, graphical mapping of the state of conservation, in particular the location and type of deterioration of 'Components', and the correspondence of alert levels (AL) for each 'Space'.

Attribute tables are defined to place all information collected during inspections within different fields. The result is a layer of knowledge that characterizes the constituent elements of the object, from which it is possible to obtain graphical maps with different colors and symbols relating to the type of data to be highlighted.
