Proceedings of the 11th MONUBASIN (2024)

# Rope access monitoring and data management of the monumental complex in Piazza dei Miracoli in Pisa

**Abstract.** Over the past few years, Opera della Primaziale Pisana has perfected a plan for periodic monitoring of the monuments in the monumental complex of Cathedral Square in Pisa. The monitoring is carried out by a group of OPA conservators specialized in rope access restoration works. The operators lower themselves from the monuments with ropes and safety harnesses to check the state of preservation of all the architectural elements.

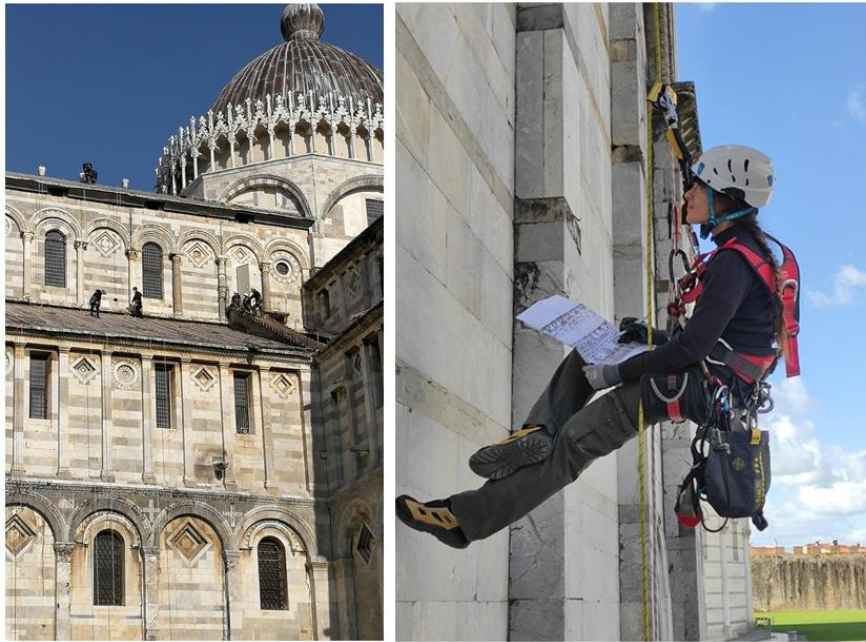
**Fig. 1-2** The conservator is mapping critical areas on the architectural survey while suspended by ropes.

In this way, in-house conservators, through periodic visual inspections directly conduct the monitoring of architectural surfaces. The purpose of the inspection is to assess the state of preservation, identify critical issues, and contribute to the maintenance planning process. To record the observations made during the inspections, it is necessary to use an accurate architectural survey of the object of investigation, such as orthophotos, 3D surveys, and architectonic plans.

The architectural survey is an essential knowledge tool that allows the identification and location of the building's components, the dimensional and morphological features of the monument, the mapping of decay and intervention areas, and the control of the evolution of deterioration over time [3].
