# International Symposium on the Conservation of Monuments in the Mediterranean Basin

Proceedings of the 11th MONUBASIN (2024)

# The application of non-destructive imaging techniques for the study and revelation of sketches under the whitewash layers of the interior walls of the House-Museum of Giannoulis Halepas, in Tinos Island, Greece

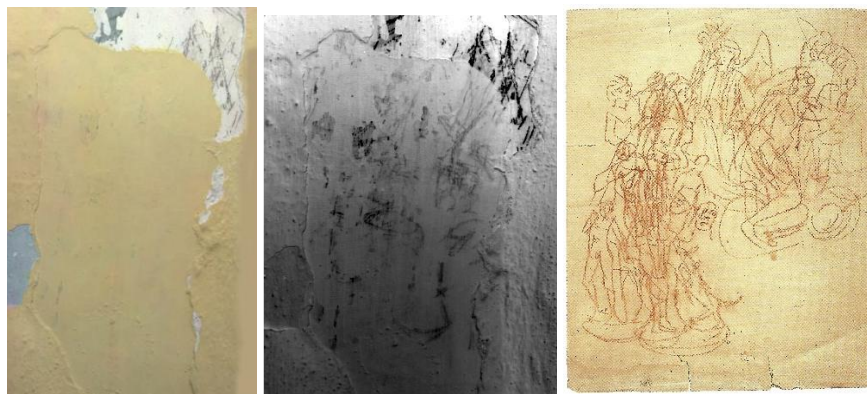
Examination of the walls by SWIR/IRRef showed that the west wall, to the left of the main entrance when entering the building, bears the largest and most complete sketch, which depicts the face of a figure (fig.3). The revealed sketch bears the characteristics of Halepas' sketches, with discontinuous lines that form the eyes, the nose and possibly the outline of the face, while around it there are irregular lines that may be parts of another composition of the artist, similar to his usual way of sketching [1,5,8]. Sketches visible to the naked eye are shown in intense black, while the ones revealed under the whitewash are recorded in a grayer tone, which is found to be a continuation of the visible ones, forming a face and possibly pleats of a cloth.

**Fig. 3.** Left: Visible image of part of the west wall. Middle: Infrared reflectogram of the same part, which reveals the sketch of a figure's head. Right: One of Halepas' sketches, which belongs to the National Gallery-Museum of Alexandros Soutsos and shows the similarities in the artist's style [5].

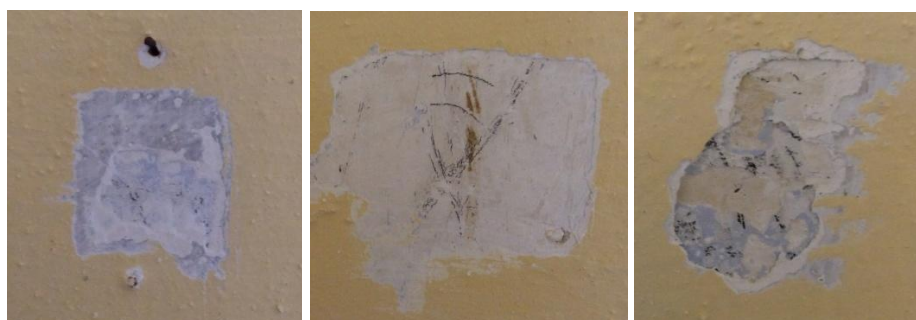
Room R2 is next to room R1, where ten (10) test sections were studied, five of which established the presence of sketches between layers (fig.5). All surfaces are plastered with the same good quality mortar about 3-4 mm thick that was found in the other two rooms (Hall and room R1). No sketches were found in this layer.

Up to 10 plaster layers were observed in room 2: white lime plasters, a bluish one, and finally, the newer yellow plaster that presently covers the walls of the Hall and room 2. The thickness of the coatings varies even in adjacent areas of the same layer. Sketches were observed on the south, east, and north walls, some of which extended over more than one layer, which proves that when they were created, the wall was already damaged and was not a single-layer substrate.

**Fig.5.** Presence of sketches found during the test sections.
