International Symposium on the Conservation of Monuments in the Mediterranean Basin

Materials characterisation and damage assessment of the ancient kiln of Kirra, Greece

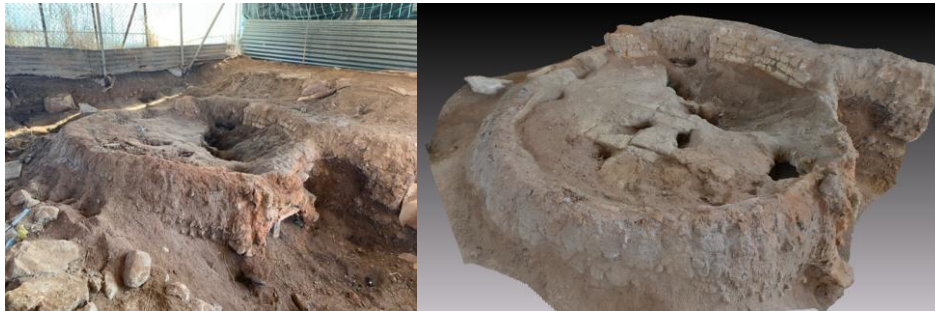
Fig. 1. The kiln as it is preserved today **Fig. 2.** 3D reconstruction of the kiln with depth measurements

- Photogrammetry was used to create 3D models of the kiln before any interventions (Fig. 2).
- Environmental monitoring was performed by collecting climate and microclimate data with the use of a data logger. The data logger measured the air temperature (T) and the relative humidity (%RH) in hourly intervals and stored the data. For the macro scale, climate conditions data were collected from meteorological stations near the archaeological site.

The structural elements of the kiln show extensive and irregular weathering. Advanced loss of material has been observed, which has resulted in a gradual change in the shape of mudbricks and mortars. The weathering of swellable clays gradually leads to the collapse and loss of the kiln's building materials. Aqueous solutions transfer soluble salts which, depending on the conditions, crystallize near the surface, causing deterioration. Furthermore, aluminosilicate minerals and clays can induce significant "hygric stress".
