Proceedings of the 11th MONUBASIN (2024)

The conservation plan for Morosini fountain: an opportunity for reflection and redefinition of the norms

Maria Deli, Maria Mertzani

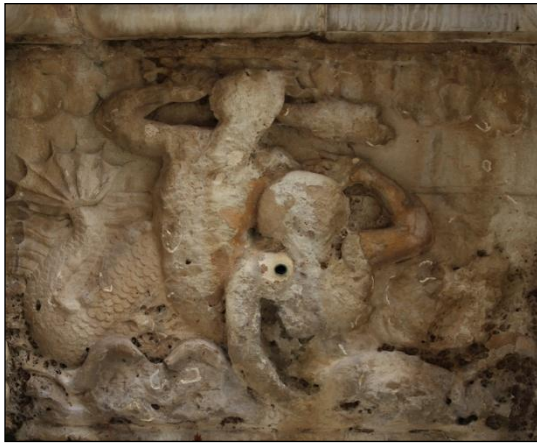
Fig. 2 Relief depicting triton waving fish [Source: DCAMM 2023]

Salts
 Discolorations
 Alveolization and cavities
 Mortars from past interventions
 Erosion
 Weathering
 Disintegration
 Biological colonization
 Mechanical damage
 Peeling
 Scaling

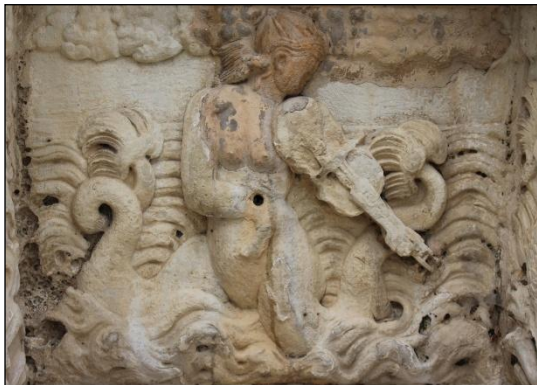
Fig. 3 Relief depicting female triton playing the violin [Source: DCAMM 2023]

Salts
 Discolorations
 Alveolization, perforations, cavities
 Mortars from past interventions
 Erosion
 Biological colonization
 Mechanical damage
 Pitting

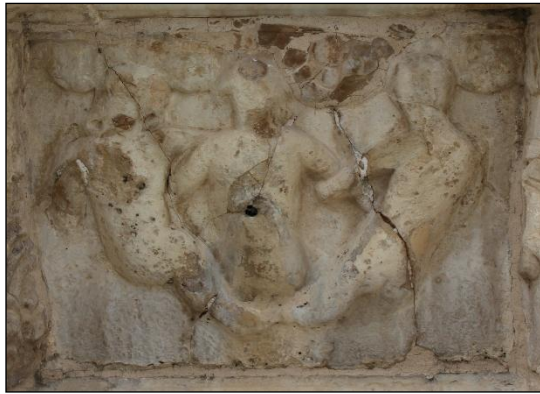
Fig. 4 Relief depicting Aphrodite's birth [Source: DCAMM 2023]

- Salts
- Discolorations
- Perforations
- Mortars from past interventions
- Erosion
- Mechanical damage
- Pitting
- Fractures
- Cracks

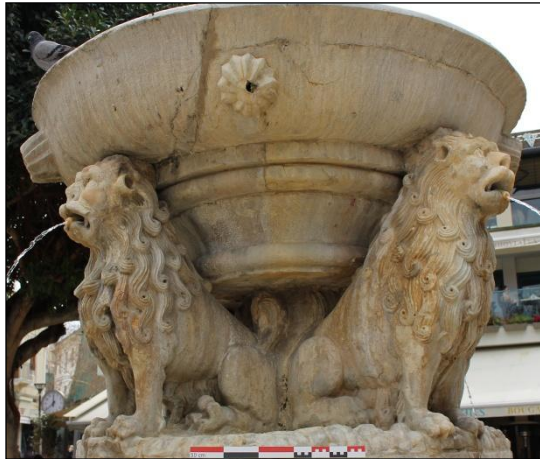
Fig. 5 Lions and upper basin [Source: DCAMM 2023]

- Salts
- Discolorations
- Perforations
- Disintegration
- Mortars from past interventions
- Erosion
- Pitting
- Fractures
- Cracks
- Crust
- Peeling
- Biological colonization
