International Symposium on the Conservation of Monuments in the Mediterranean Basin

The conservation plan for Morosini fountain: an opportunity for reflection and redefinition of the norms

Photographic documentation of decay

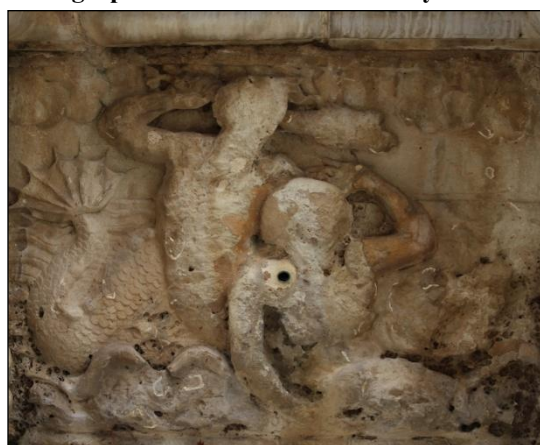
Fig. 2 Relief depicting triton waving fish [Source: DCAMM 2023]

Salts
 Discolorations
 Alveolization and cavities
 Mortars from past interventions
 Erosion
 Weathering
 Disintegration
 Biological colonization
 Mechanical damage
 Peeling
 Scaling

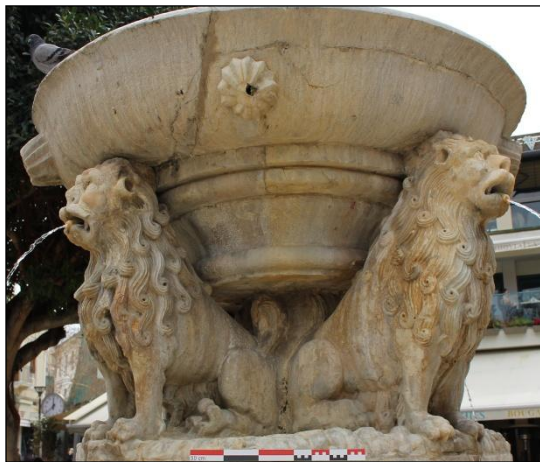
Fig. 5 Lions and upper basin [Source: DCAMM 2023]

- Salts
- Discolorations
- Perforations
- Disintegration
- Mortars from past interventions
- Erosion
- Pitting
- Fractures
- Cracks
- Crust
- Peeling
- Biological colonization
