Proceedings of the 11th MONUBASIN (2024)

# Revisiting the Mosaic of the Masks on Delos: A Comprehensive Condition Survey

**Abstract.** A condition survey was conducted on the 'Mosaic of the Masks' located in the homonymous Hellenistic house on Delos to reassess its condition twenty years after its conservation. This mosaic adorns the central symposium room and comprises a central geometric carpet with a 3D cube pattern, along with figurative bands featuring theatrical masks and floral motifs. Extensive and drastic conservation treatment was applied to the central carpet, involving its detachment in sections and reinstallation on a new, purpose-built setting bed, while the peripheral sections were preserved in situ. The particularly poor state of preservation necessitated thorough research into the weathering processes and the factors affecting its condition. Investigation into the archival records, the original constituents, conservation materials, and past conservation interventions were conducted to better understand the deterioration processes. Photogrammetric methods were employed in the study and documentation of surface geometry, while the cohesion of the substrate was exam

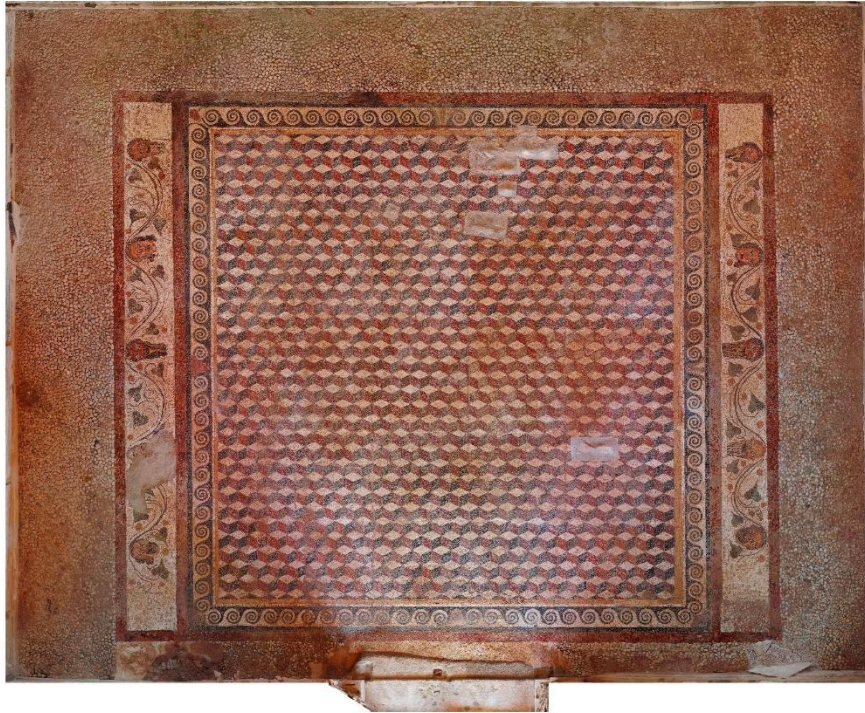
The mosaic under study measures 9.12 x 7.09 meters and features a central geometric pattern composed of '3D cubes,' a recurring motif in Hellenistic mosaics. This design is characterized by the arrangement of cubes to create a three-dimensional effect. The central pattern is bordered by a decorative band of waves, with two lateral bands on the east and west, each showcasing five theatrical masks, interwind with floral motifs. The outer band is plain, giving the illusion of a big carpet on the floor (Fig.1).

**Fig. 1.** Orthophoto of the mosaic of the Masks, 9.12 x 7.09 meters (by C. Maris)

Both handheld digital cameras and drones were utilized to capture images. A first set of 974 images were acquired before cleaning, followed by a set of 857 images after dry cleaning. The first two sets of images were shot from a height of approx. 0,5 m, with a 70% overlap, a rather time-consuming and labor-intensive process. Image processing was similarly challenging due to the large number of images. A third set of 187 images were acquired with a drone from a steady distance of 3 m. The 3D model, the orthophotos, and the digital elevation model (DEM) provided metric information and enabled the study and documentation of surface geometry alterations related to natural deterioration and previous conservation treatments. The orthophotos served as a base for accurately mapping surface and structural conditions, while the point cloud and the DEM provided the basis for monitoring subsequent changes in the geometry of the mosaic, allowing for the assessment of the evolution of decay (Figs 1, 4).

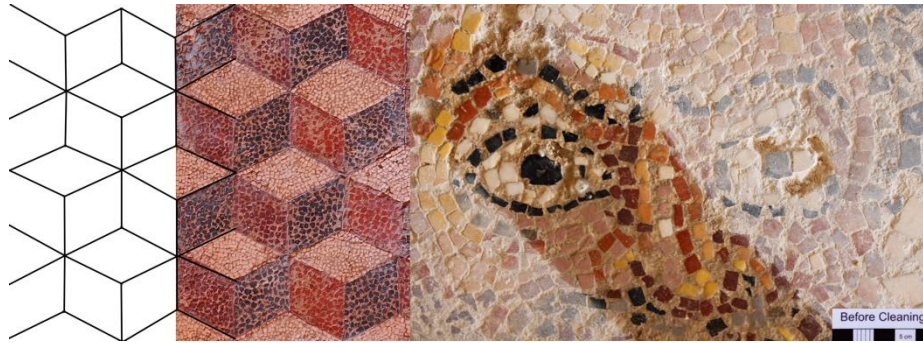
A variety of materials and fabrication techniques are employed. The sides of the cubes are set in *opus segmentatum*, characterized by the random setting of irregular red and black tesserae with wide and irregular interstices (Fig. 2). In contrast, the top of the cubes is set in *opus tessellatum*, characterized by a well-organized *andamento*, using white tesserae of approx. 1 cm side arranged in concentric lozenges [3]. Additionally, lead strips [4,5] are used to define the sides of the rhombuses that form the three-dimensional cubes and the outlines of the waves. *Opus vermiculatum* is used in the masks, and *opus tessellatum* in their background, the floral motifs, and the rest of the decorative bands. Glass tesserae are used in a few details of the masks while the rest of the mosaic is made of stone tesserae.

**Fig. 2.** Detail of the 3D cube pattern of the central mosaic carpet (left) and the masks (right) (photo and drawing by S. Minetou).
