Proceedings of the 11th MONUBASIN (2024)

Revisiting the Mosaic of the Masks on Delos: A Comprehensive Condition Survey

Abstract. A condition survey was conducted on the 'Mosaic of the Masks' located in the homonymous Hellenistic house on Delos to reassess its condition twenty years after its conservation. This mosaic adorns the central symposium room and comprises a central geometric carpet with a 3D cube pattern, along with figurative bands featuring theatrical masks and floral motifs. Extensive and drastic conservation treatment was applied to the central carpet, involving its detachment in sections and reinstallation on a new, purpose-built setting bed, while the peripheral sections were preserved in situ. The particularly poor state of preservation necessitated thorough research into the weathering processes and the factors affecting its condition. Investigation into the archival records, the original constituents, conservation materials, and past conservation interventions were conducted to better understand the deterioration processes. Photogrammetric methods were employed in the study and documentation of surface geometry, while the cohesion of the substrate was examined t

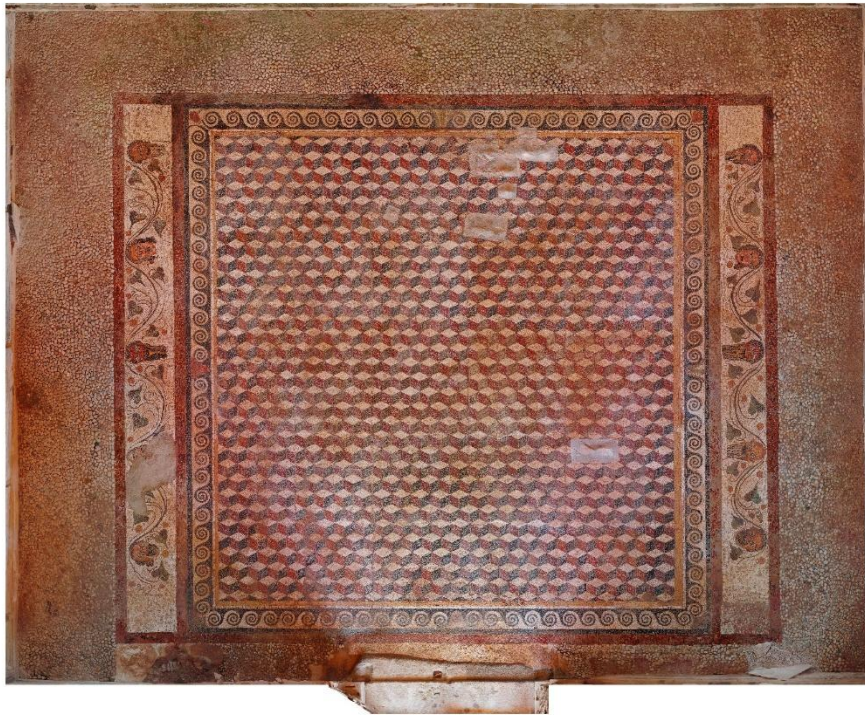
Fig. 1. Orthophoto of the mosaic of the Masks, 9.12 x 7.09 meters (by C. Maris)

The mosaic under study measures 9.12 x 7.09 meters and features a central geometric pattern composed of '3D cubes,' a recurring motif in Hellenistic mosaics. This design is characterized by the arrangement of cubes to create a three-dimensional effect. The central pattern is bordered by a decorative band of waves, with two lateral bands on the east and west, each showcasing five theatrical masks, interwind with floral motifs. The outer band is plain, giving the illusion of a big carpet on the floor (Fig.1).

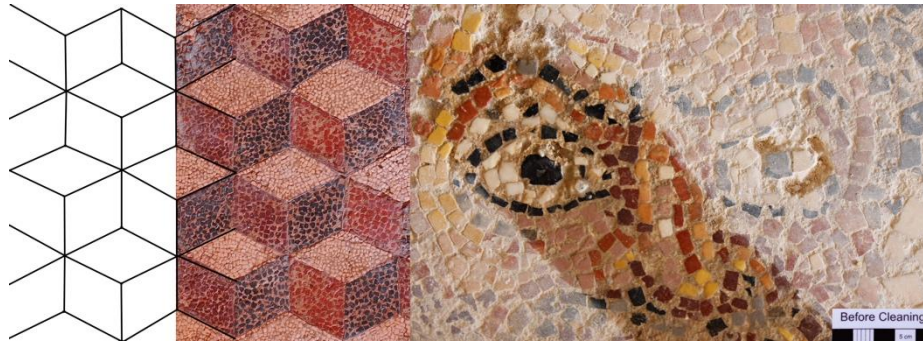
Fig. 2. Detail of the 3D cube pattern of the central mosaic carpet (left) and the masks (right) (photo and drawing by S. Minetou).

A variety of materials and fabrication techniques are employed. The sides of the cubes are set in *opus segmentatum*, characterized by the random setting of irregular red and black tesserae with wide and irregular interstices (Fig. 2). In contrast, the top of the cubes is set in *opus tessellatum*, characterized by a well-organized *andamento*, using white tesserae of approx. 1 cm side arranged in concentric lozenges [3]. Additionally, lead strips [4,5] are used to define the sides of the rhombuses that form the three-dimensional cubes and the outlines of the waves. *Opus vermiculatum* is used in the masks, and *opus tessellatum* in their background, the floral motifs, and the rest of the decorative bands. Glass tesserae are used in a few details of the masks while the rest of the mosaic is made of stone tesserae.
