Proceedings of the 11th MONUBASIN (2024)

11th International Symposium on the Conservation of Monuments in the **Mediterranean Basin**

Exploring Material, Techniques and Information Management for
Conservation, Urban Restoration and Cultural Heritage

17-19 of June 2024 Athens, Greece

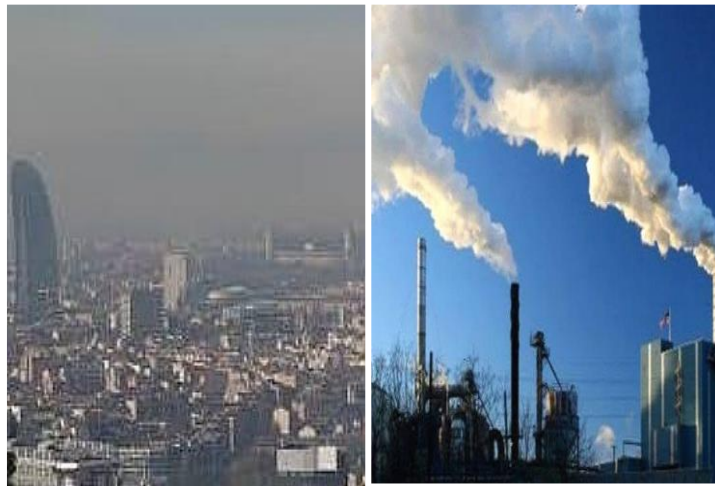
Figure 12

Among the damage sources are those remarkable for air pollution (**fig. 12**). The great variety of compounds that circulate in the atmosphere enhances stone damage. The accumulation of organic and inorganic pollutants in the air tends to occur on the exposed surfaces of monuments and react with the mineralogical components of their substrates, lacking any form of regeneration.

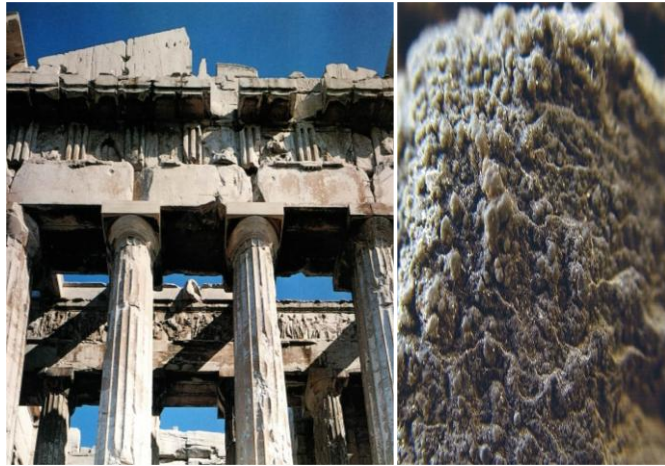
Figure 13

The industrial development played a significant role in the formation of black crusts (**fig. 13**), which cover and disintegrate the substrates. In particular, the black crusts composed of sulphates (gypsum) are today the most visible consequence of the aggressiveness suffered by the monuments.

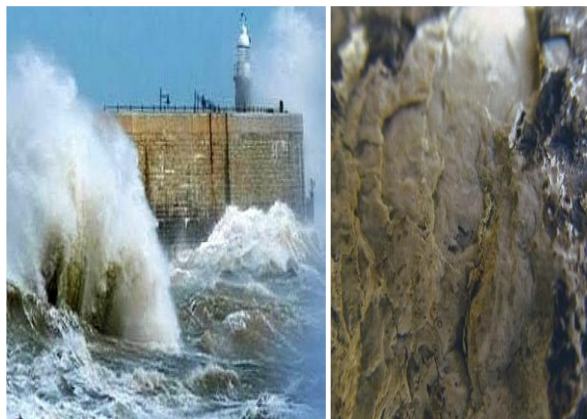
Figure 14

Sulphates often act in concert with marine aerosols (**fig. 14**), which are introduced directly into the atmosphere by the sea in the form of drops and minute particles. The salt spray provokes disaggregation, exfoliation, cracking, fissuring, and detachment.

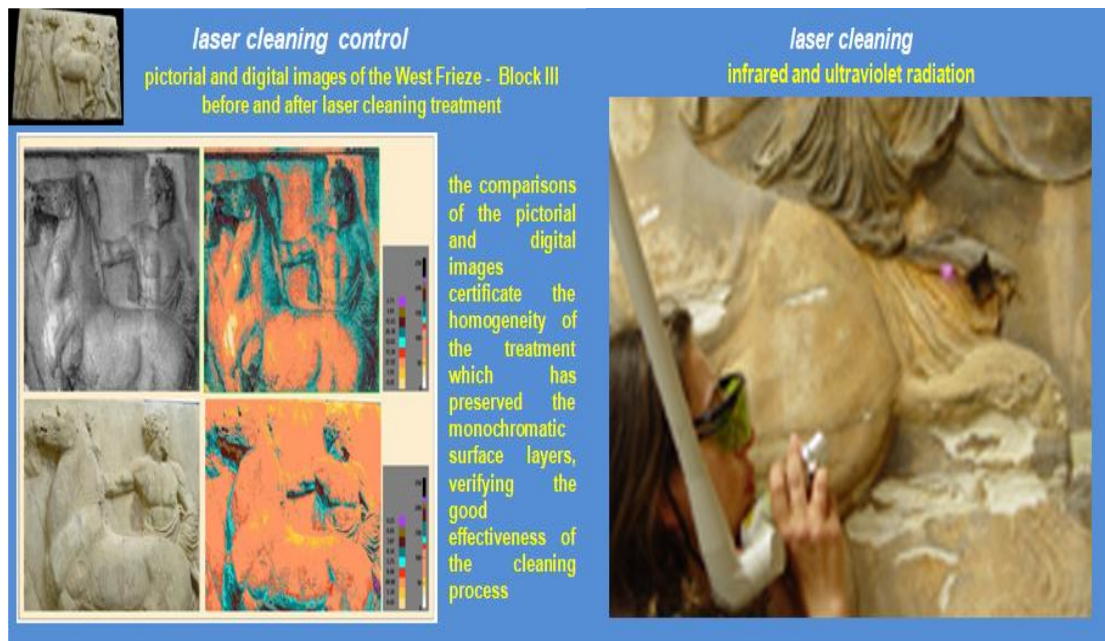
Figure 19

Regarding this, I would like to show you an example of digital images (**fig. 19**) that I processed for the Parthenon West Frieze blocks when I was invited by the head of the Documentation Office of the Acropolis Restoration Service to assess the effects of laser cleaning on marble surfaces before and after treatment.

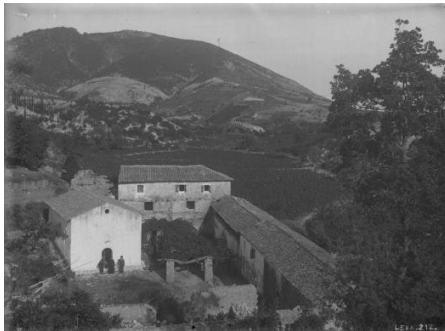
Fig. 1. Historical photograph, 1960s.

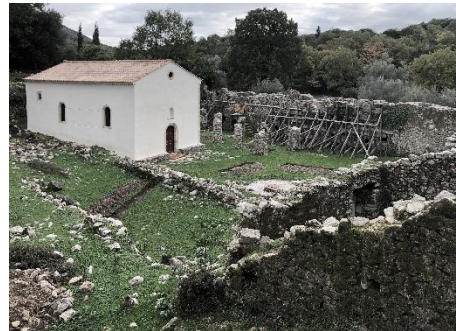
Fig. 2. Recent photograph, 2020.

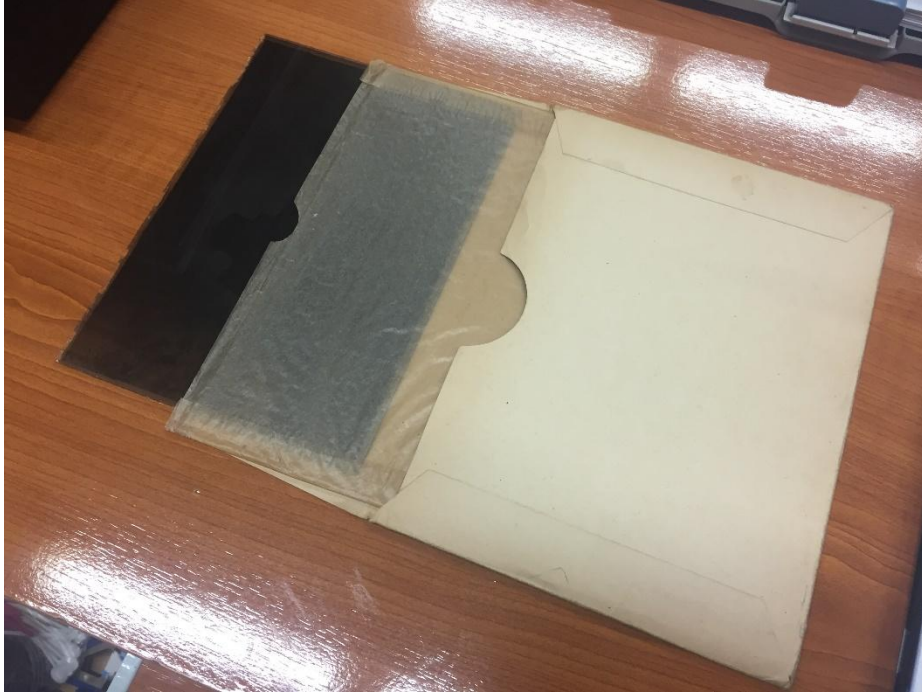
Fig. 1 - Sopoćani glass plate

Wall paintings of the Sopoćani Monastery (founded in the second half of the 13th century) are recorded as glass dry plates, which have been deposited at the Institute for the Protection of Historical Monuments of Serbia. The glass plates were taken in 1954 as visual documentation, and the author has assessed the conservation state of the wall paintings by comparing them with glass plates which are under ongoing archiving. The comparative study is carried out by applying images from three different times: photographs recorded in 1926 before the first intervention of modern restoration, glass dry plate images dating 1954, and digital data taken by the author in 2017. By analyzing the differences between the multiple images of long intervals of time, the author clarified that wall paintings at Sopoćani are comprehensively in good condition. Besides image comparisons, the results of a field survey done by the author and field measurements carried out in 2017 for further discussion have been introduced. As a result, no critical damage to the mural structure or serious changes to its appearance were identified. The conservation state of the wall paintings remained satisfactory, mainly because the restoration works carried out between 1926 and 2017 had been modest enough, allowing the wall paintings to retain the stability of the original production.

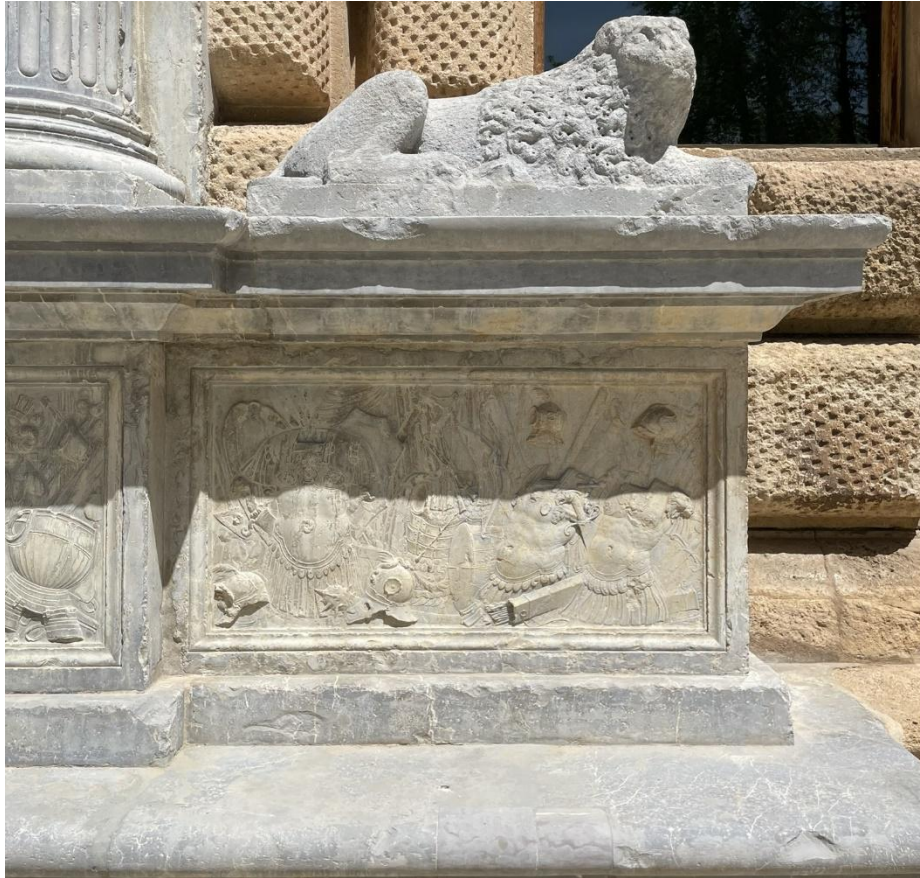
Fig. 1. Giorgio Ghelfi, 2024. Detail of the facade of the Palace of Charles V within the Patronato de la Alhambra y el Generalife.

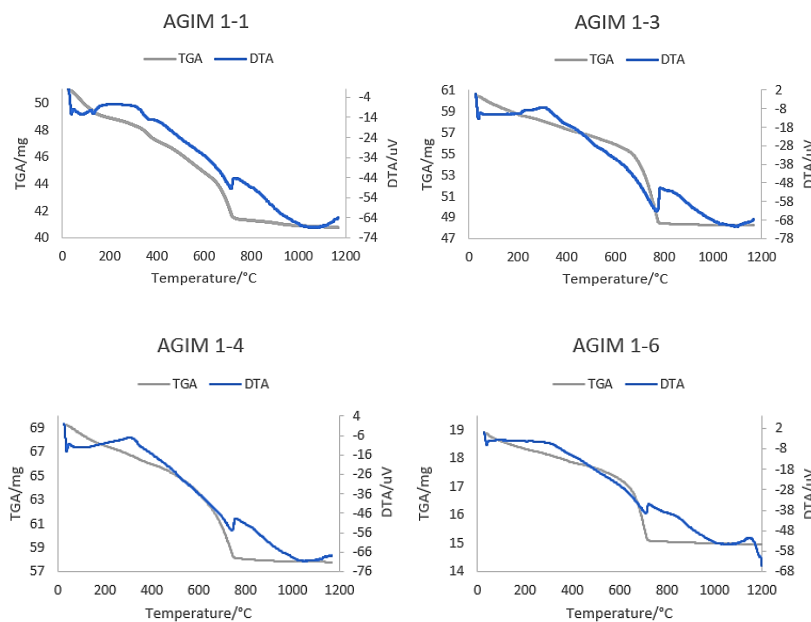
Fig. 3. DTA/TGA curves of the mortar samples under study.

The thermal analysis results confirmed that the mortar samples under study may be classified as strongly hydraulic. The graphs obtained during these analyses (Fig. 3) correspond to similar graphs found in the literature for hydraulic lime mortars [12].

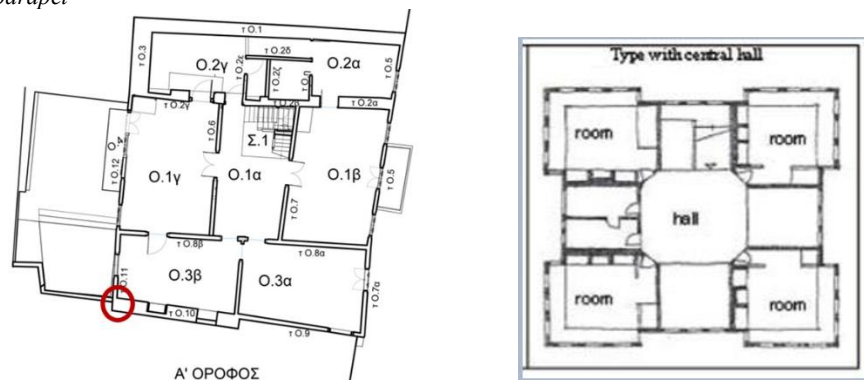
Fig. 6a Repair -reinforcement in SW corner (red cycle) in all floors due to the (arbitrary) placement of a pillar of a neighbor building! **6b** The formation of the 1st floor proves the relation with Ottoman similar layouts.

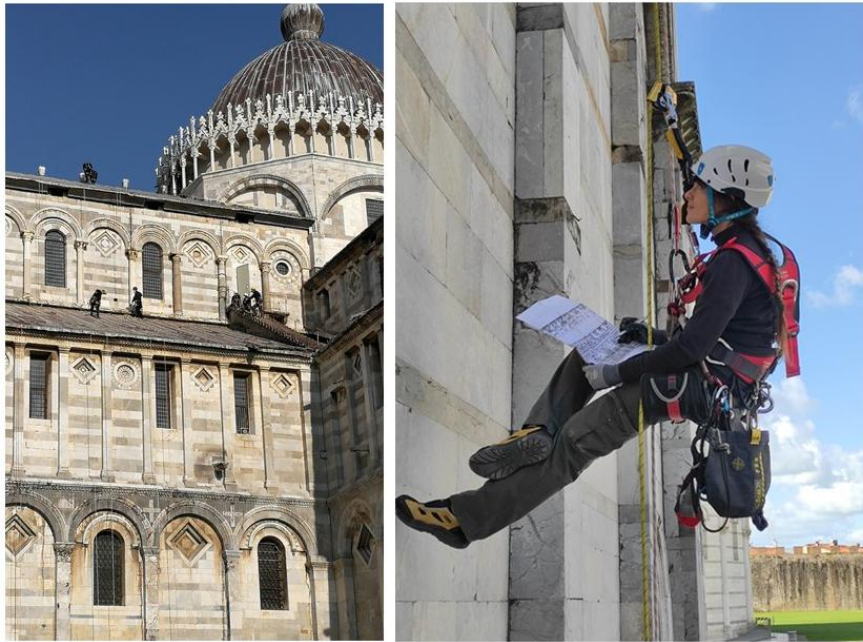
Fig. 1-2 The conservator is mapping critical areas on the architectural survey while suspended by ropes.

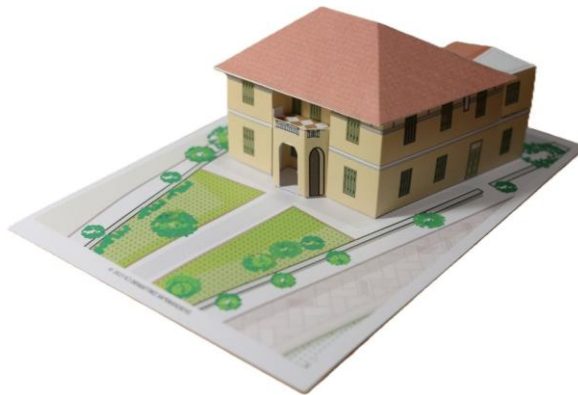
Fig. 3. Paper reconstruction of the Old Town Hall of Vyronas.

The principal product is the 3D papercraft, which consists of color printed pre-cut pieces on 3 A4 sheets, plus a color base on an extra sheet. By assembling the pieces, the user can build the paper reconstruction of the old Town Hall and soon-to-be History Museum (Figure 3). The key points of the building's history are presented on the information sheet included in the packaging. Through the AR application, the user who has assembled the model can be guided through a more detailed version of the building's history, including some accounts and anecdotes about the centrality of this landmark for the everyday life of Vyronas residents through the decades. The user also gains access to the VR video about the forthcoming Museum and its first exhibition.

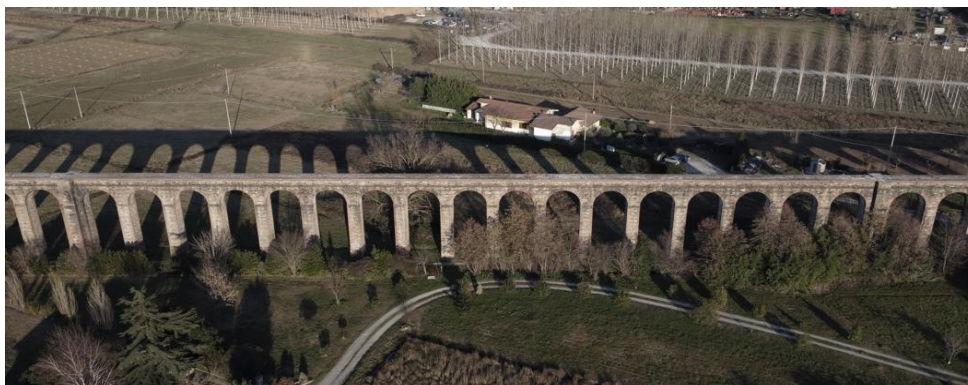
Fig. 1. Lucca, acquedotto del Nottolini, vista aerea del doppio condotto su archi, 2023.

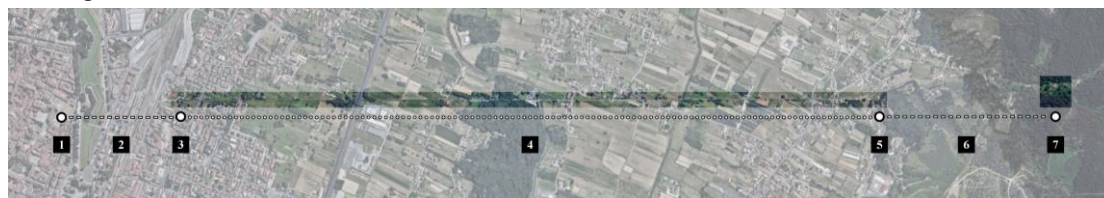
Fig. 2. Diagram of the Lucca aqueduct system.

1. The city fountains
2. The penstock
3. The terminal temple of San Concordio
4. The double conduit on arches
5. The initial temple of Guamo
6. Underground conduit
7. The system of fountains and the *serra vespaiaata*

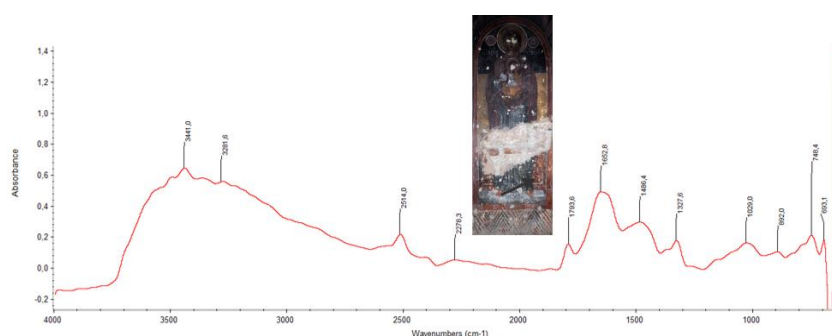
Fig. 4. FT-IR spectrum of red pigment in the wall painting No.6.

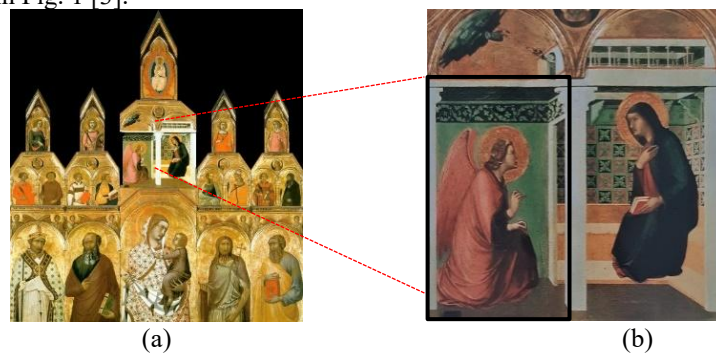
Fig. 1. (a) A photograph of the polyptych, (b) a zoomed view on the reproduced part.

This study focuses on a reproduction of a 1320 polyptych by Pietro Lorenzetti, preserved in Arezzo, Italy, as shown in Fig. 1 [3].

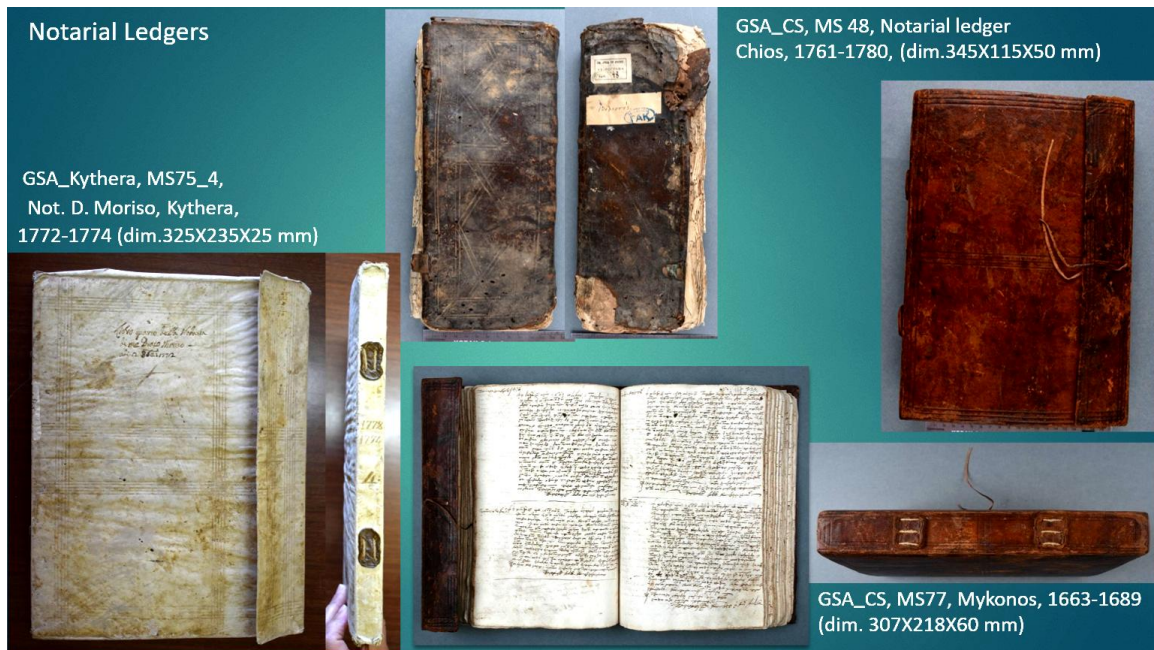
Fig. 1. Some types of notarial bindings (GSA-Central Services, Athens and GSA-Kythera).

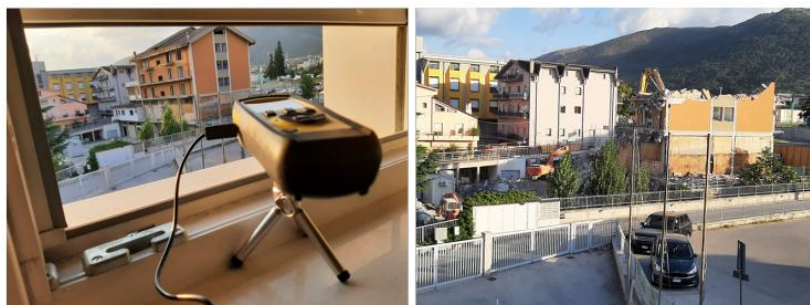
Fig. 1. Target building and instrument setup

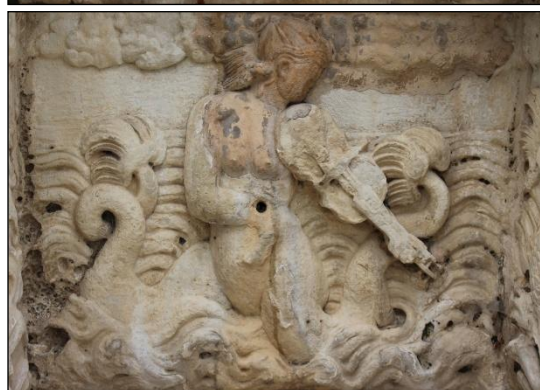
Fig. 3 Relief depicting female triton playing the violin [Source: DCAMM 2023]

Salts
 Discolorations
 Alveolization, perforations, cavities
 Mortars from past interventions
 Erosion
 Biological colonization
 Mechanical damage
 Pitting

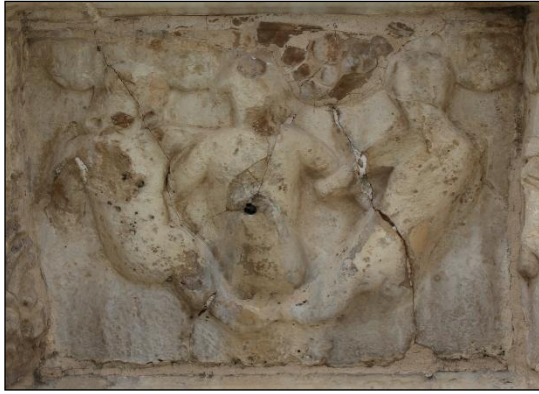
Fig. 4 Relief depicting Aphrodite's birth [Source: DCAMM 2023]

- Salts
- Discolorations
- Perforations
- Mortars from past interventions
- Erosion
- Mechanical damage
- Pitting
- Fractures
- Cracks

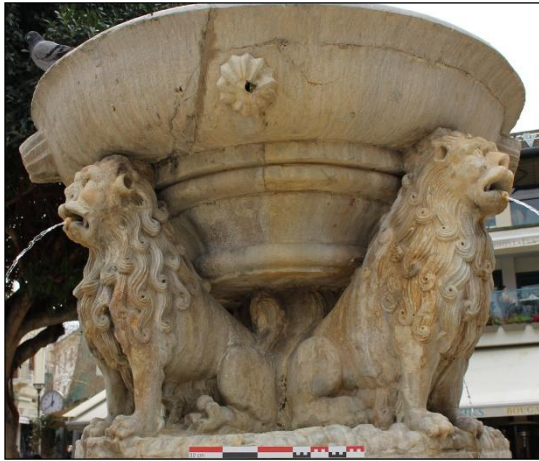
Fig. 5 Lions and upper basin [Source: DCAMM 2023]

- Salts
- Discolorations
- Perforations
- Disintegration
- Mortars from past interventions
- Erosion
- Pitting
- Fractures
- Cracks
- Crust
- Peeling
- Biological colonization

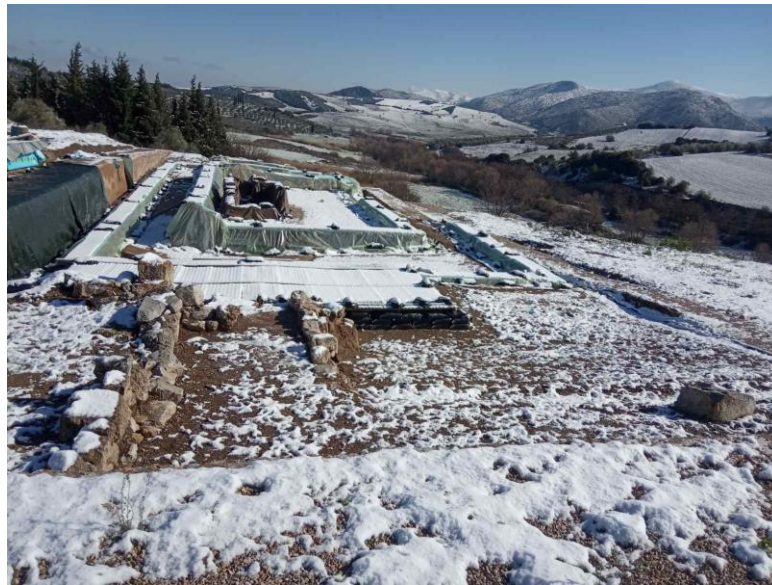
Fig. 4. Kalapodi. Fthiotis Greece (2021). The ruins of the site are protected during winter by seasonal covering with geotextile and insulation panels. Photo: Ch. Vaporakis, DAI Athen.

The phenomenon of frost poses a constant danger to the site's materials, which, in combination with the vulnerable structural materials, causes decay problems. Currently this is solved by seasonal covering with geotextile and insulation panels. Due to climate change, in the future all these problems will become intense. The site participates as a case study for the TRIQUETRA program that started on 01/01/2023 and will last for 3 years. As part of the program TRIQUETRA, an integrated methodological model to protect archaeological remains at Kalapodi from frost, is proposed.

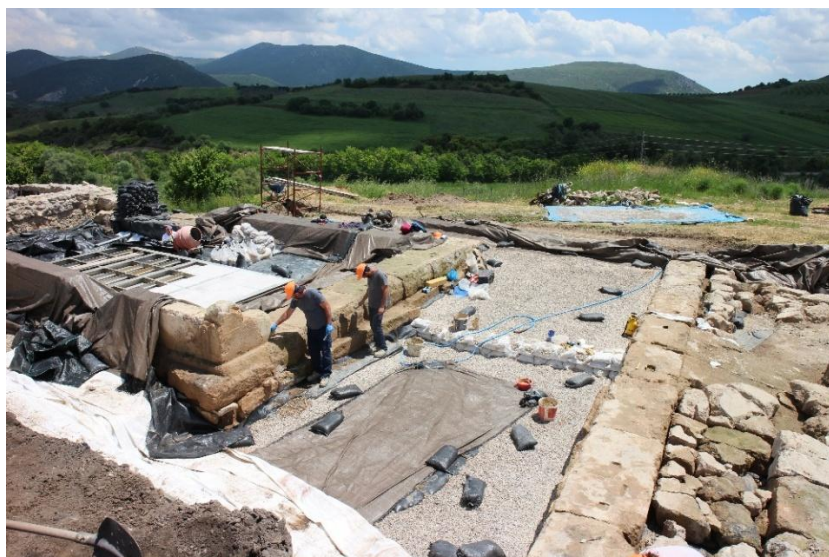
Fig. 7. Kalapodi. Fthiotis Greece. During conservation works. Photo: T. Bilis, DAI Athen.

The systematic conservation works were aimed at the structural strengthening of the various materials, and included cleaning of members, welding, sealing, grouting, consolidation and aesthetic restoration works. They were carried out in different phases from 2018 to 2021 by both external conservation crews and DAI's specialized staff (see Fig. 7, 8).

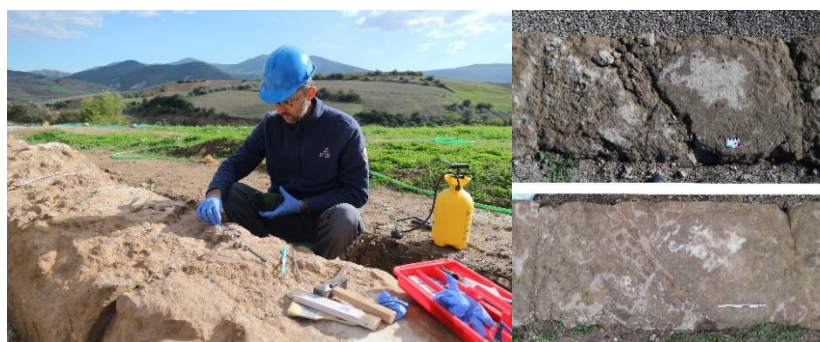
Fig. 8. Kalapodi. Fthiotis Greece. During conservation works (left), before and after conservation of a limestone from the archaic temple (right). Photo: E. Stamou (left) A. Sotiropoulos (right), DAI Athen.

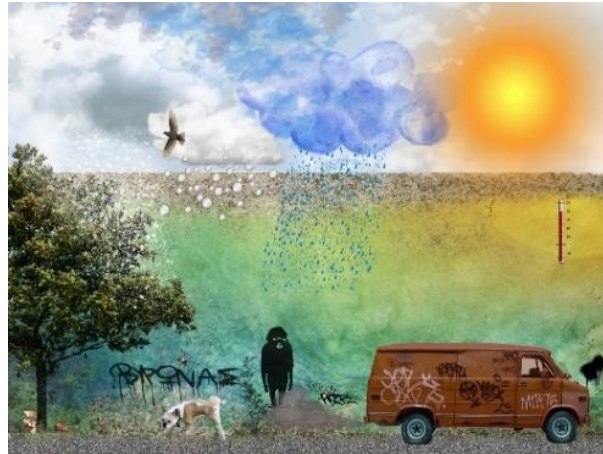
Fig. 1. The impact of extreme, uncontrolled outdoor environmental conditions and human interventions, leading to the rapid deterioration of street art.

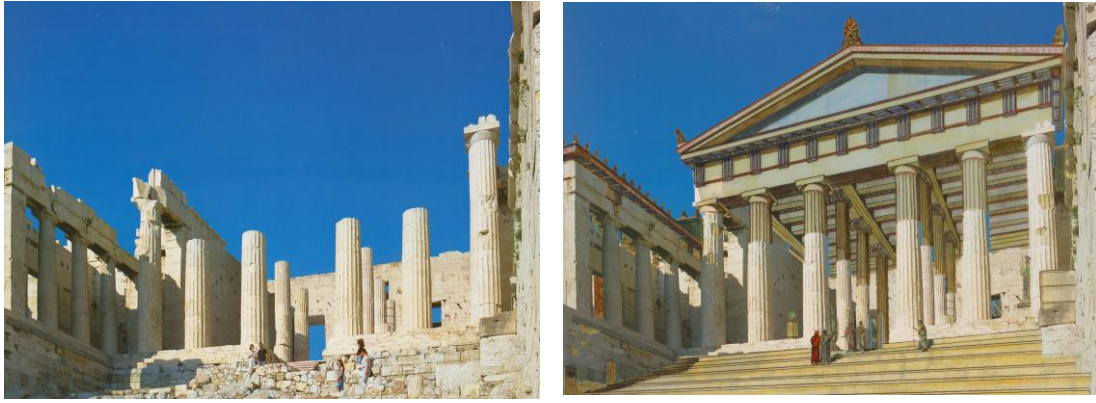
Fig. 1. Propylaea, Acropolis: elaboration of the monument's architectural survey and its graphic representation (G. Antoniou, 2008, *Ancient Greece. The Monuments then and now*, p. 12, Propylaea depicted before restoration works).

The monument has been architecturally surveyed and studied [1], as its restoration project was included in the major restoration and consolidation works to be carried out on the Acropolis hill by the Acropolis Restoration Service (YSMA). The conducted 2D drawings have been most useful, as in this case, the combination of the photographic material and formerly collected records were combined with free hand reconstruction and representation of all the missing parts of the monument.

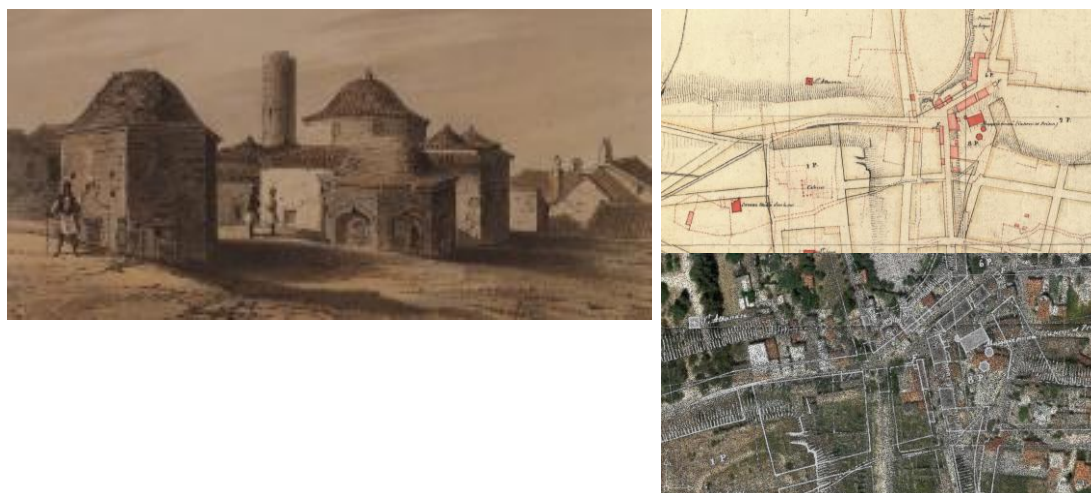
Fig. 3. The central area of Ancient Corinth -Du Moncel, (Mosqué turque a Corinth, 1843). The topographical map by P. Peytier (1829) & the relevant overlapping of the under-study area with its important Ottoman monuments, using images extracted from Google Earth.

The map (now in the Depot de la Guerre/Cartes/4.10.C.65.1.0057, 86x58,50 pencil drawing, ink, Paris, 1829) [6], was depicting important monuments of the area. A part of Peytier's plan was enlarged, and the "cut image" was overlapped on the extracted data from Google Earth, showing the modern urban fabric, producing stunning results³: the urban form of the village has remained quite unaltered, as the lines depicting small streets and plots of land were traced till our modern times (see Fig. 3).

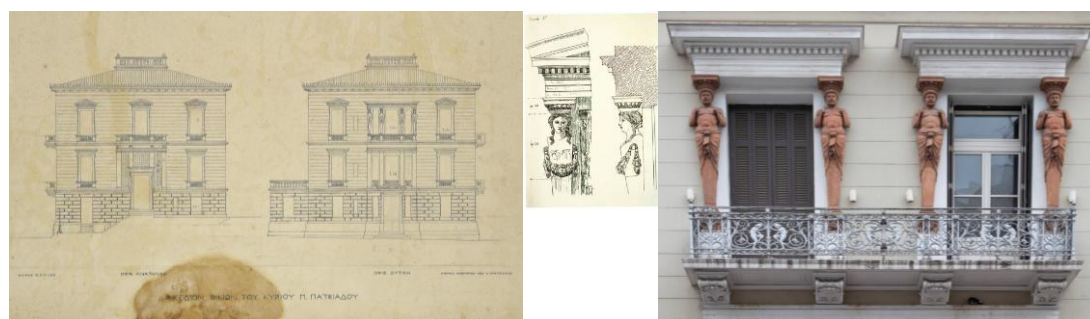
Fig. 4. The twin Patsiadou mansions (1870), hand-drawn side façade design by Ernst Ziller -plan kept at the Ziller Archive at the National Gallery-A. Soutsos Museum, Athens and architectural elements deriving from other buildings designed by the architect, used for their detailed digital representation: i.e., a drawing for a Karyatide at Loverdou mansion façade in Athens, his home in late 19th c. & details from Sp. Metaxa mansion in Piraeus, depicting 4 male figures.

During the elaboration of the digital renderings, it became necessary to conduct a comparative study of other Ziller's works in Athens since many architectural structural elements were not well defined -the watercolour plans in scale 1:50 were rather vague. Other projects were studied, such as the Ziller-Loverdou private house (Mavromichali 6 str., Athens), "Mpageion hotel" (Omonoia square, Athens city centre), as well as Sp. Metaxa mansion (Vas. Georgiou str., Piraeus), since similar architectural features found in these buildings were copied and applied. As an outcome, it seems that many of the drawn architectural morphological & decorative elements were either not realized or had been modified in later interventions (see Fig. 4).

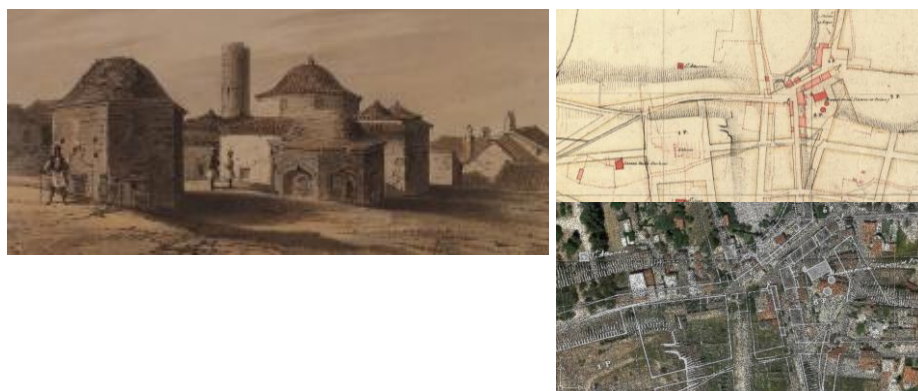
Fig. 3. The central area of Ancient Corinth -Du Moncel, (Mosqué turque a Corinth, 1843). The topographical map by P. Peytier (1829) & the relevant overlapping of the under-study area with its important Ottoman monuments, using images extracted from Google Earth.

The map (now in the Depot de la Guerre/Cartes/4.10.C.65.1.0057, 86x58,50 pencil drawing, ink, Paris, 1829) [6], was depicting important monuments of the area. A part of Peytier's plan was enlarged, and the "cut image" was overlapped on the extracted data from Google Earth, showing the modern urban fabric, producing stunning results³: the urban form of the village has remained quite unaltered, as the lines depicting small streets and plots of land were traced till our modern times (see Fig. 3).

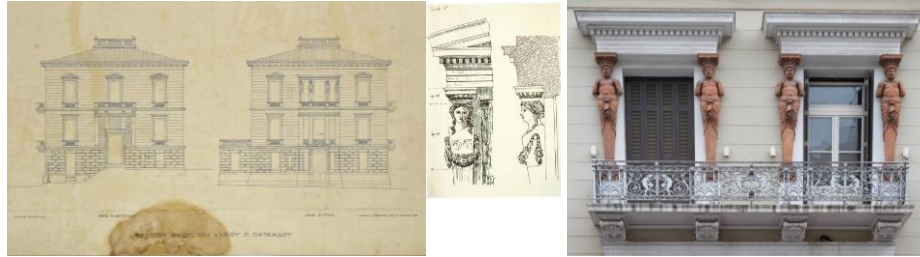
Fig. 4. The twin Patsiadou mansions (1870), hand-drawn side façade design by Ernst Ziller -plan kept at the Ziller Archive at the National Gallery-A. Soutsos Museum, Athens and architectural elements deriving from other buildings designed by the architect, used for their detailed digital representation: i.e., a drawing for a Karyatide at Loverdou mansion façade in Athens, his home in late 19th c. & details from Sp. Metaxa mansion in Piraeus, depicting 4 male figures.

watercolour plans in scale 1:50 were rather vague. Other projects were studied, such as the Ziller-Loverdou private house (Mavromichali 6 str., Athens), “Mpageion hotel” (Omonoia square, Athens city centre), as well as Sp. Metaxa mansion (Vas. Georgiou str., Piraeus), since similar architectural features found in these buildings were copied and applied. As an outcome, it seems that many of the drawn architectural morphological & decorative elements were either not realized or had been modified in later interventions (see Fig. 4).
