Proceedings of the 11th MONUBASIN (2024)

Restoration Study of late Ottoman Terzakis House in Nafplion

Georgios P. Antoniou

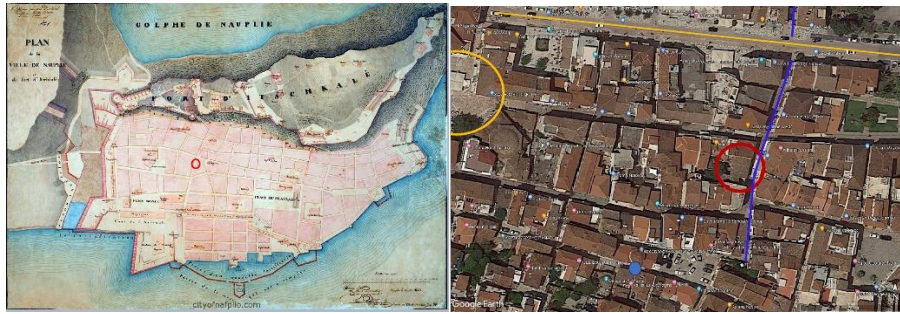
Fig 1a. Historical map of Nafplion after the new blocks (in South) and in red mark the position of Terzaki mansion [1] **Fig 1b** “Terzaki” mansion at Nafplion traditional town grid red circle (the blue cycle indicates the site of Kapodistrias murder! The yellow line indicates the position of the early Venetian *South* coastal wall. Yellow arc indicates the area of Nafplion central square!

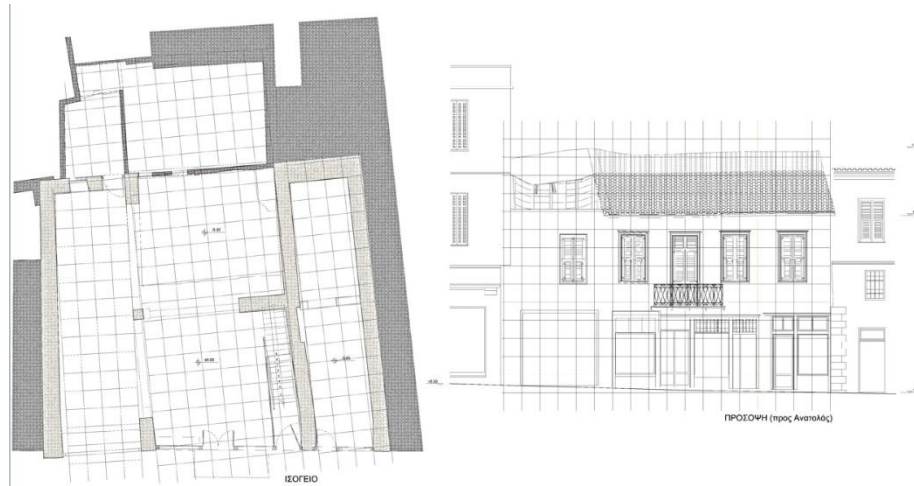
Fig 4. Metrological Analysis–Study according to Ottoman cubit (*zira*) of 75,8 cm valid in the late 18th century [5]
© G. Antoniou
