HNPS Advances in Nuclear Physics

Vol 24 (2016)

Resurrected from the dead: Full characterization of an old HPGe detector using γ -ray and CT tomographies coupled to standard calibration techniques and simulations

Abstract A decommissioned co-axial HPGe detector has been recently acquired and returned to operational mode in an effort to build an environmental radiation spectrometer at the University of Athens. The new counting station, GEROS (Germanium for Environmental RadiOactivity Studies), was fully characterized prior to operation to obtain detailed information on its linear response, efficiency and energy resolution. In addition to using point-like calibration sources (^{60}Co , ^{137}Cs , ^{152}Eu and ^{226}Ra), several bulk sample geometries were calibrated by means of an IAEA standard, focusing on soils, sediments and solid materials.

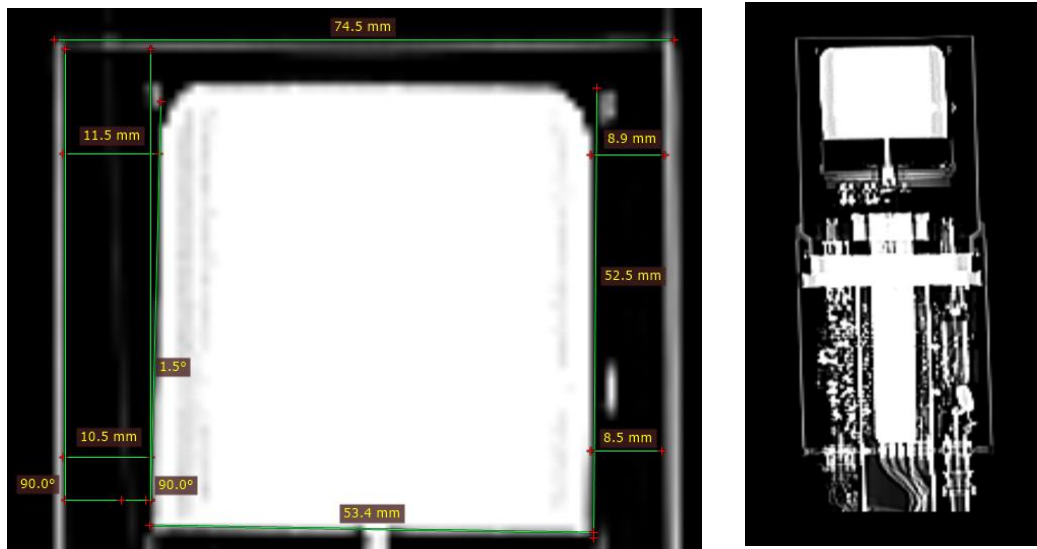
Fig. 9. Side (left) and full view (right) of the detector under X-rays in a medical CT scanner

All results mentioned above, extracted by means of γ tomography were subsequently verified by 3D Computer-Aided Tomography (CT). Several slices of the detector were reconstructed producing pictures as the ones illustrated in Fig. 9. The discovered tilt of the crystal was found undoubtedly to exist (side view) inside the aluminum cup. The external diameter was measured at 53.4 mm, however it was impossible to see the hole on the inside, since the X-rays from the CT, even at the maximum available energy, are fully absorbed within some mm after entering the Ge ($Z=32$) crystal. It is worth noting that the diameter measured with the X-rays matches the nominal value on the text sheet. Comparing it with the 47 mm resulted from the γ -ray tomography, where only the active material can be measured, a difference of 4 mm appears. This points to a rather thick dead layer of 2 mm having formed around its surface due to its prolonged period of inactivity. An additional result of the CT scan is the measurement of the crystal length that could not be deduced by the γ -tomography measurements.
