HNPS Advances in Nuclear Physics

Resurrected from the dead: Full characterization of an old HPGe detector using γ -ray and CT tomographies coupled to standard calibration techniques and simulations

Abstract A decommissioned co-axial HPGe detector has been recently acquired and returned to operational mode in an effort to build an environmental radiation spectrometer at the University of Athens. The new counting station, GEROS (Germanium for Environmental RadiOactivity Studies), was fully characterized prior to operation to obtain detailed information on its linear response, efficiency and energy resolution. In addition to using point-like calibration sources (^{60}Co , ^{137}Cs , ^{152}Eu and ^{226}Ra), several bulk sample geometries were calibrated by means of an IAEA standard, focusing on soils, sediments and solid materials.

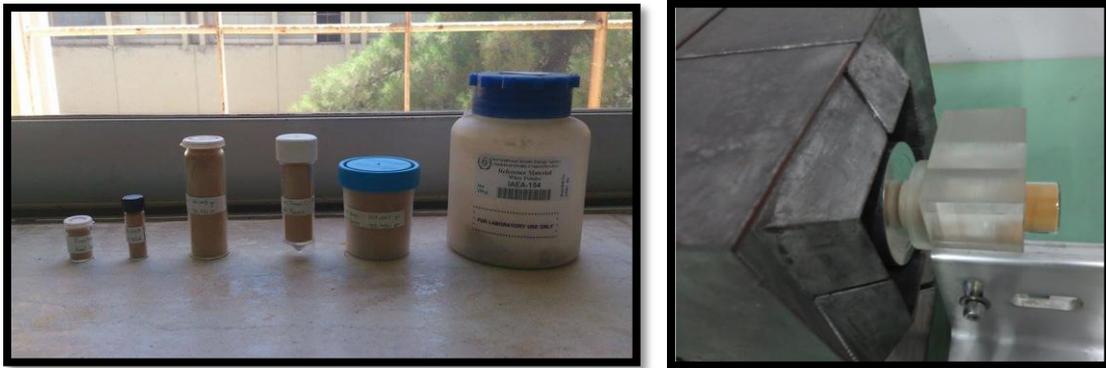
Fig. 1. The bulk samples and the IAEA reference material (left), and the set up (right)

In addition, as GEROS' intended use is environmental radioactivity measurements, its efficiency was measured with five bulk samples of different cylindrical geometries, all containing quantities of an IAEA reference material (IAEA-154) of known specific activity. The low-activity samples were placed directly on the detector window (Fig. 1) mounted in a specially manufactured holder to maximize counting rates. From the measured counting rates of each sample (average measurement time 24 h), the conversion factors to actual specific activity have been determined.

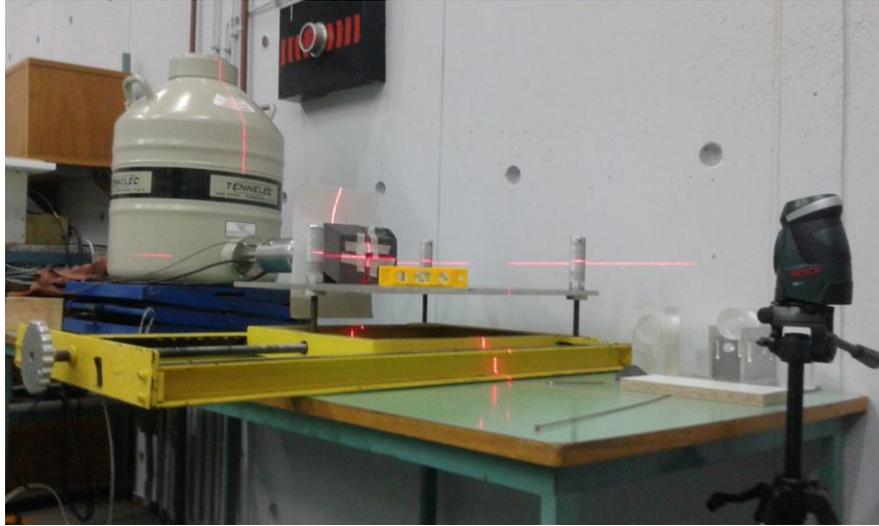
Fig. 2. The experimental set up for γ -ray tomography

For those measurements, a new set up was constructed. GEROS was placed on a X-Y motion platform. A custom collimator made out of four 5 cm x 5 cm Pb bricks was put together to shape a 3 mm x 3 mm hole, which was initially placed coaxially to the HPGe crystal with the help of an alignment laser (see Fig. 2). A weak ^{134}Cs source ($t_{1/2} = 2.0652$ y) was placed behind the hole of the collimator. On the window of the detector there was a predefined grid of positions, which was used to specify the coordinates of the collimated γ -rays spot. As the X-platform was manually moved to a new grid position, the γ -rays irradiated a different part of the crystal.

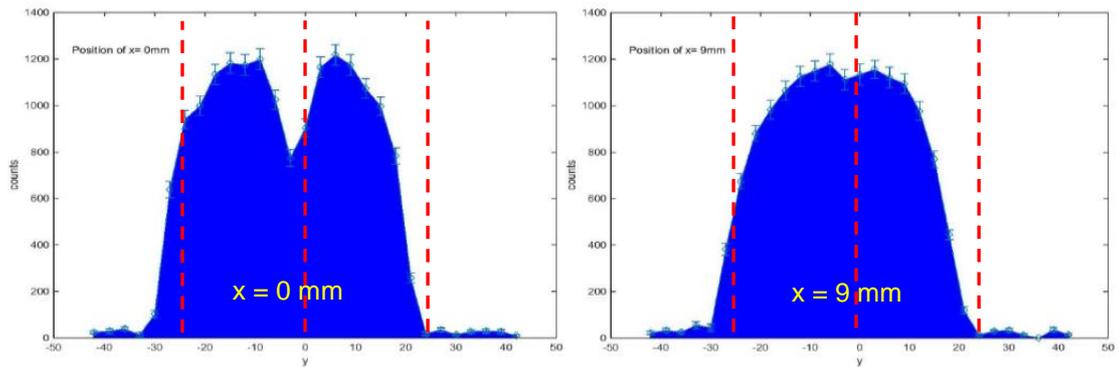
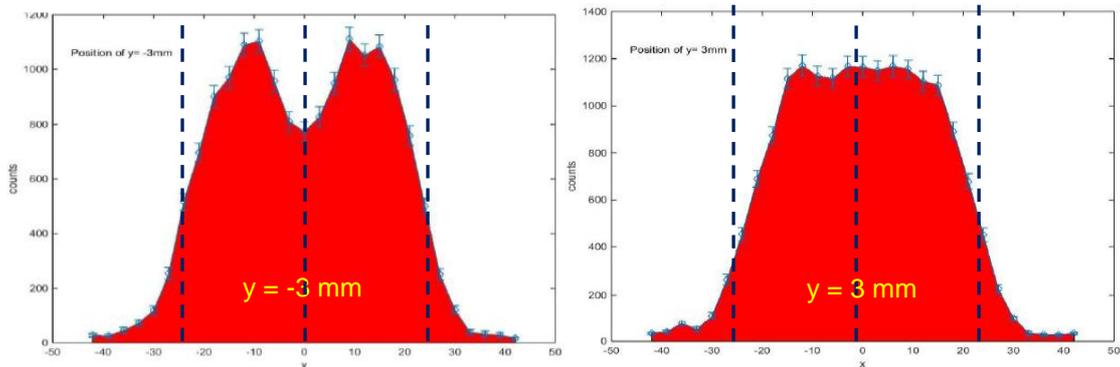
Fig. 3. Diagrams of counts a) vertical and b) horizontal scanning. The dashed lines indicate the nominal center and outer bounds of the crystal.

Diagrams of counts vs. X and Y positions were drawn as seen in Fig. 3. In the expected co-axial geometry, the different thickness of the Ge layer absorbing the emitted source photons would result in a non-uniform distribution of counts in X and Y scans.

An asymmetry in the Y axis is apparent in Fig. 3, near the edges of the graphs, that concerns the orientation of the crystal inside the cup. The edges have been used to estimate the internal and external diameter of the crystal. The data near the edges were initially fitted with a sigmoid function. Keeping in mind that the geometry of the crystal is coaxial, the internal diameter was estimated by measuring the distance between the mean values of the two curves that appear around the center. In analogy to that, the external diameter was estimated for the two curves at the edges. This procedure was repeated for both dimensions and the diameters were calculated.

Furthermore, a closer look at Fig. 3, considering the orientation of the crystal, suggests a slight tilt of the crystal inside the aluminum cup. Specifically, while comparing the two scans at the estimated center in both dimensions, the crystal appears to be symmetrical towards the x axis, whereas in the y axis there is a profound asymmetry. This is in agreement with the γ rays penetrating more material on the negative side of the y axis than on the positive, an observation that could only be explained by a tilt.

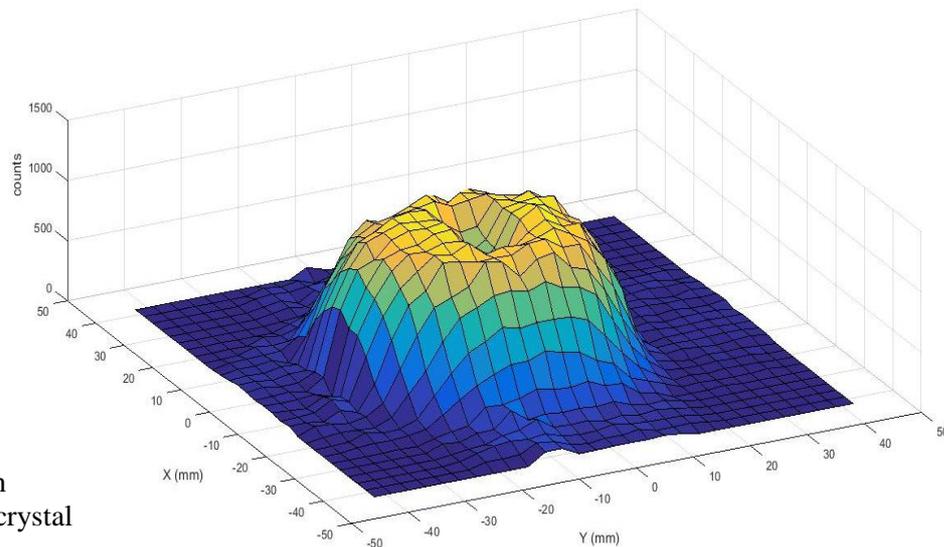
Fig. 4. A 3D reconstruction model of the crystal

By combining all 2D diagrams, a 3D model of the crystal was reconstructed (Fig. 4). It is important to clarify that the 3D model does not show the actual shape of the crystal, but the absorbed energy of the γ -rays penetrating the crystal, throughout its whole volume. In essence, it is the reconstruction of the absorption coefficient 3D map, which is however inversely related to the geometry of the crystal.

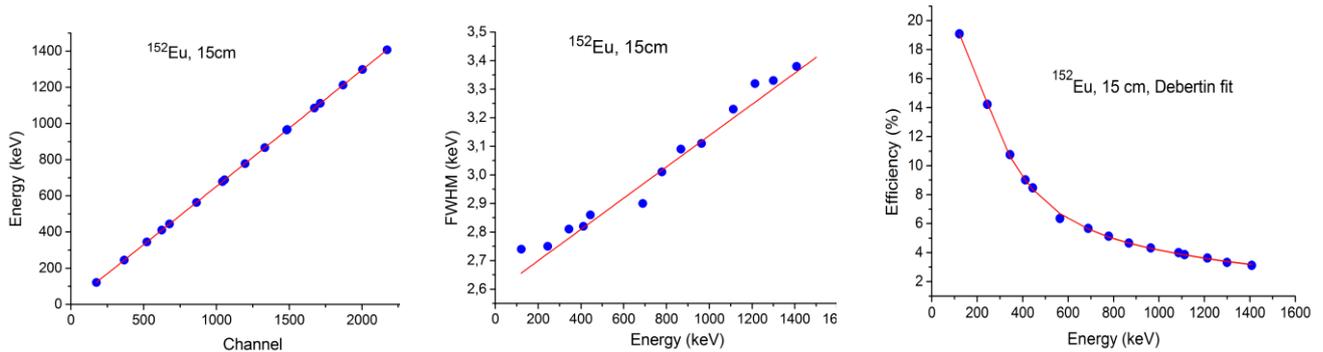
Fig. 5. Linearity (left), energy resolution (middle) and absolute efficiency (right) curves deduced from a ^{152}Eu source placed at 15 cm from the detector's window and fitted with Debertin's equation

In Fig. 5 the linearity, energy resolution and absolute efficiency curves are depicted. The fit with a function $F(x)=Cx^2+Bx+A$ has produced the values $A=9.2$ keV, $B=0.6435$ keV/chn

and $C=9.2 \times 10^{-8} \text{ keV/chn}^2$. The excellent agreement between fit and data, as well as the tiny value of C, confirms the linearity of the detector.

From the value of FWHM at 1332 keV, equal to 3.3 keV, a significant degradation of the resolution is evident when compared to the manufacturer's original value (2.06 keV). Despite this loss of resolution, attributed to the long inactivity, GEROS can still be used reliably for environmental studies. Moreover, the absolute efficiency curve is typical for a detector of its kind (in Fig. 5 a Debertin fit is shown) and is in the order of 3-5% for most of naturally occurring isotopes (^{238}U series, ^{40}K etc).

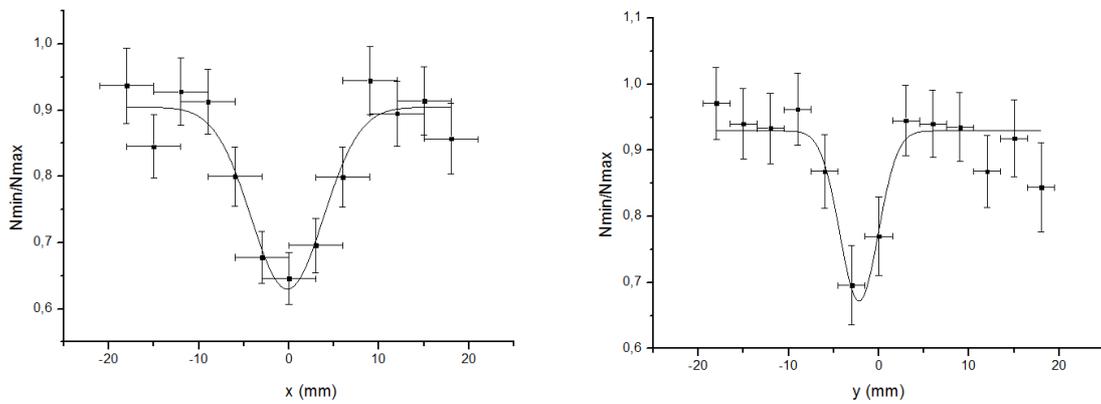
Fig. 6. Gaussian fits to locate the minima in X and Y scans.

The exact position of the crystal's center was pursued in terms of finding the minima of the ratio N_{\min}/N_{\max} . Gaussian fits were performed on these ratios (Fig. 6) suggesting a minimum exists at (0,-2 mm), hinting a crystal displacement.

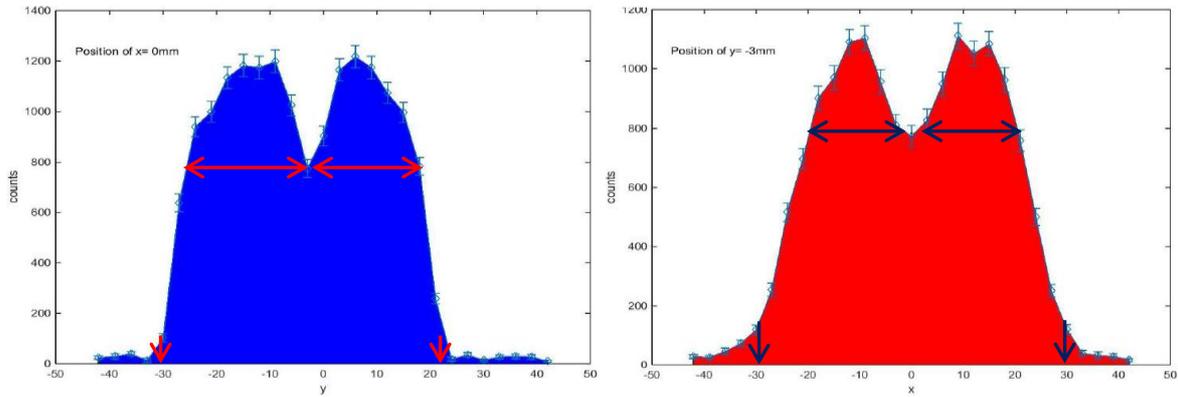
Fig. 7. Central scanings of vertical and horizontal dimensions of the crystal

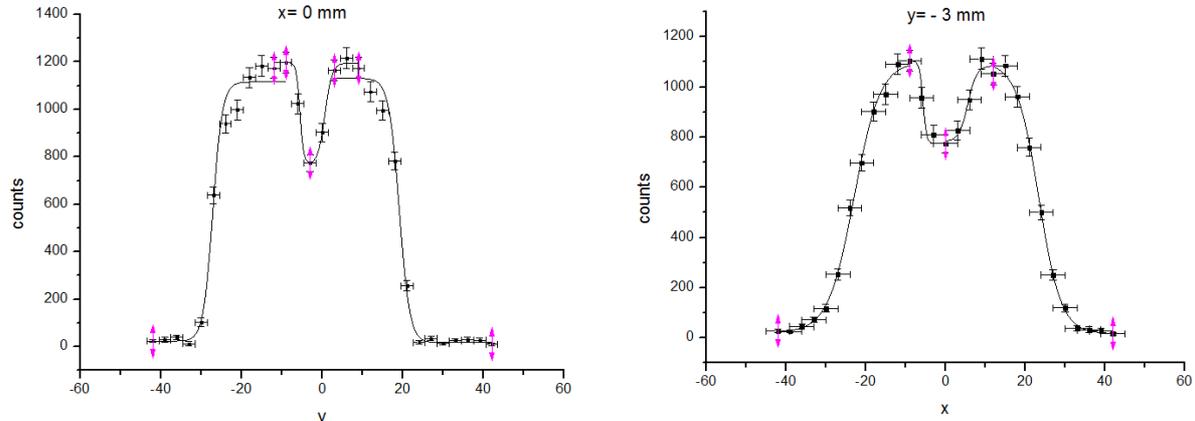
Fig. 8. Sigmoid fit of the central scans of the crystal

Despite a difference existing between the values estimated for X and Y scans at first sight, the two values agree well within error. Consequently, the weighted average values were calculated as 9 and 47 mm for the internal and external diameter of the crystal, respectively.

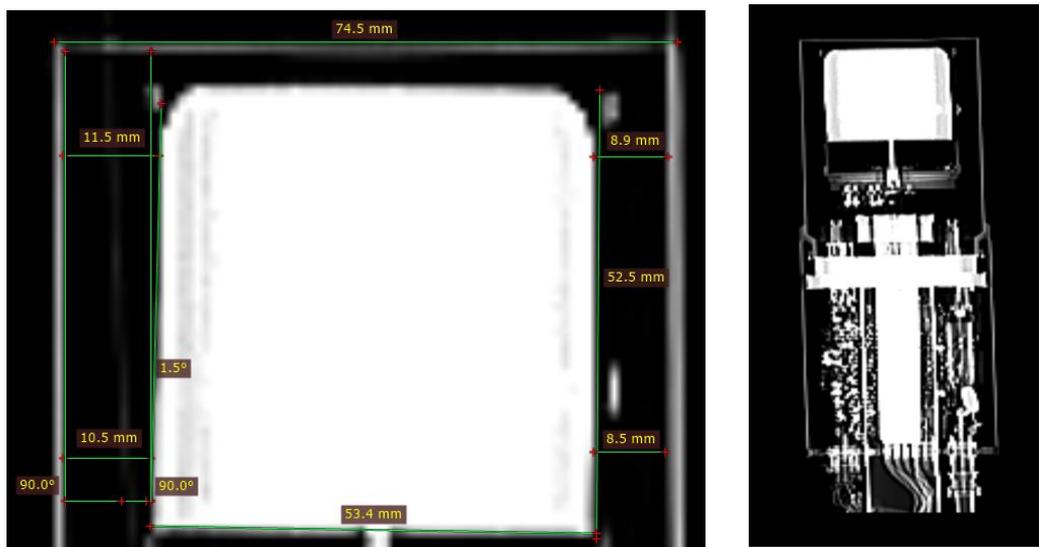
Fig. 9. Side (left) and full view (right) of the detector under X-rays in a medical CT scanner

All results mentioned above, extracted by means of γ tomography were subsequently verified by 3D Computer-Aided Tomography (CT). Several slices of the detector were reconstructed producing pictures as the ones illustrated in Fig. 9. The discovered tilt of the crystal was found undoubtedly to exist (side view) inside the aluminum cup. The external diameter was measured at 53.4 mm, however it was impossible to see the hole on the inside, since the X-rays from the CT, even at the maximum available energy, are fully absorbed within some mm after entering the Ge ($Z=32$) crystal. It is worth noting that the diameter measured with the X-rays matches the nominal value on the text sheet. Comparing it with the 47 mm resulted from the γ -ray tomography, where only the active material can be measured, a difference of 4 mm appears. This points to a rather thick dead layer of 2 mm having formed around its surface due to its prolonged period of inactivity. An additional result of the CT scan is the measurement of the crystal length that could not be deduced by the γ -tomography measurements.

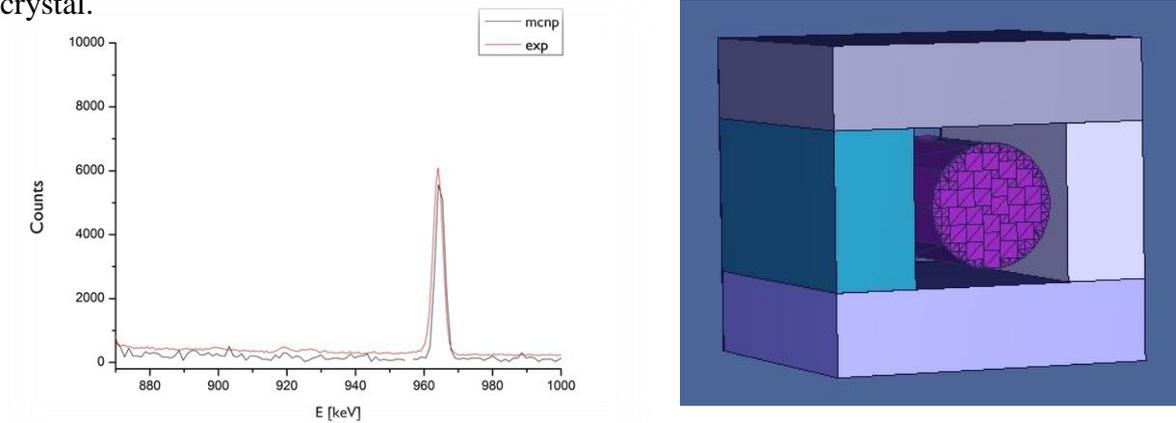
Fig. 10. (Left) Experimental and MCNP-simulated spectra for a randomly selected ^{152}Eu peak (Right) The model geometry used in MCNP5 simulations

All extracted information on the geometry and the efficiency of the detector were used to carry out a Monte Carlo simulation using MCNP5 [4]. This work is still in progress, however preliminary results appear in good agreement with the experiment (Fig. 10). Additional simulations will focus on estimating the dead layer thickness and active volume of the Ge crystal.
