Annual Symposium of the Hellenic Nuclear Physics Society

Resurrected from the dead: Full characterization of an old HPGe detector using γ -ray and CT tomographies coupled to standard calibration techniques and simulations

Abstract A decommissioned co-axial HPGe detector has been recently acquired and returned to operational mode in an effort to build an environmental radiation spectrometer at the University of Athens. The new counting station, GEROS (Germanium for Environmental RadiOactivity Studies), was fully characterized prior to operation to obtain detailed information on its linear response, efficiency and energy resolution. In addition to using point-like calibration sources (^{60}Co , ^{137}Cs , ^{152}Eu and ^{226}Ra), several bulk sample geometries were calibrated by means of an IAEA standard, focusing on soils, sediments and solid materials.

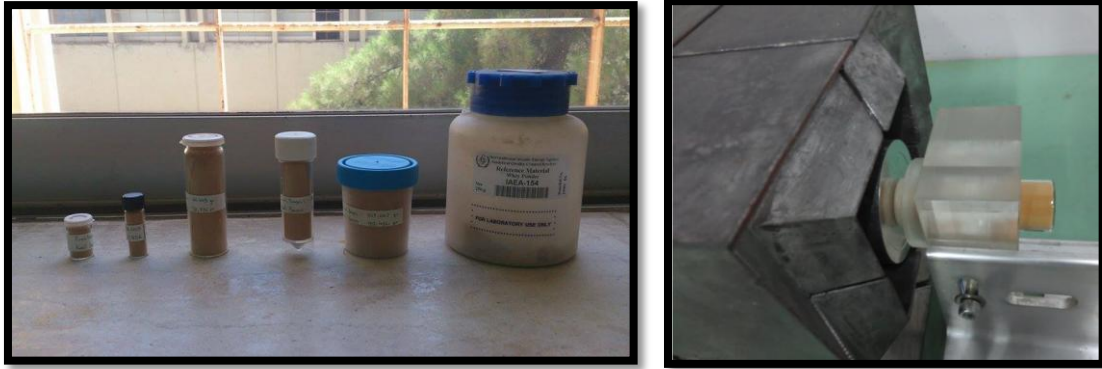
Fig. 1. The bulk samples and the IAEA reference material (left), and the set up (right)

In addition, as GEROS’ intended use is environmental radioactivity measurements, its efficiency was measured with five bulk samples of different cylindrical geometries, all containing quantities of an IAEA reference material (IAEA-154) of known specific activity. The low-activity samples were placed directly on the detector window (Fig. 1) mounted in a specially manufactured holder to maximize counting rates. From the measured counting rates of each sample (average measurement time 24 h), the conversion factors to actual specific activity have been determined.

The results of GEROS calibration using the IAEA reference material for several sample geometries produced the conversion factors shown in Table 1. It has to be noted that the IAEA standard is only rich in ^{137}Cs and ^{40}K . In the future, standards of different composition will be used additionally.

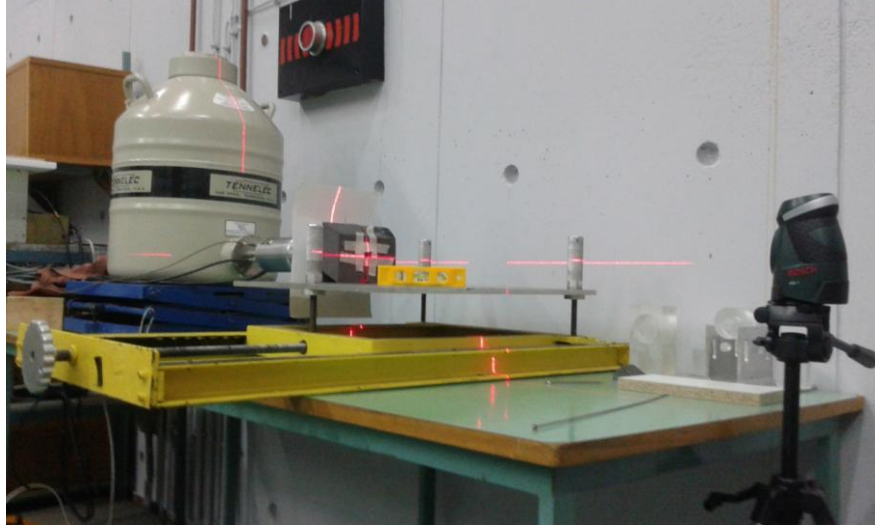
For those measurements, a new set up was constructed. GEROS was placed on a X-Y motion platform. A custom collimator made out of four 5 cm x 5 cm Pb bricks was put together to shape a 3 mm x 3 mm hole, which was initially placed coaxially to the HPGe crystal with the help of an alignment laser (see Fig. 2). A weak ^{134}Cs source ($t_{1/2} = 2.0652$ y) was placed behind the hole of the collimator. On the window of the detector there was a predefined grid of positions, which was used to specify the coordinates of the collimated γ -rays spot. As the X-platform was manually moved to a new grid position, the γ -rays irradiated a different part of the crystal.

Fig. 2. The experimental set up for γ -ray tomography

In total, 710 10-min long measurements were performed, scanning the full window of the aluminum cup, with a step of 3 mm for each direction. The 604.7 keV (I% = 97.62%) and 795.9 keV (I% = 85.53%) ^{134}Cs peaks were analyzed in the spectra.

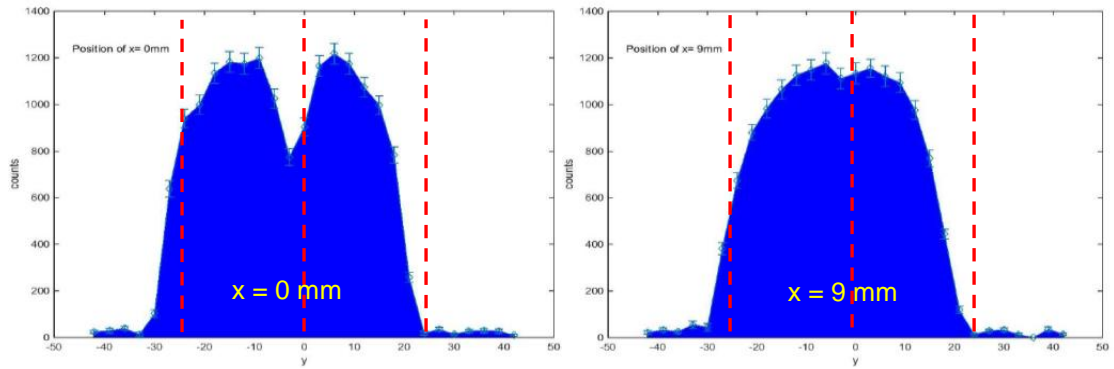
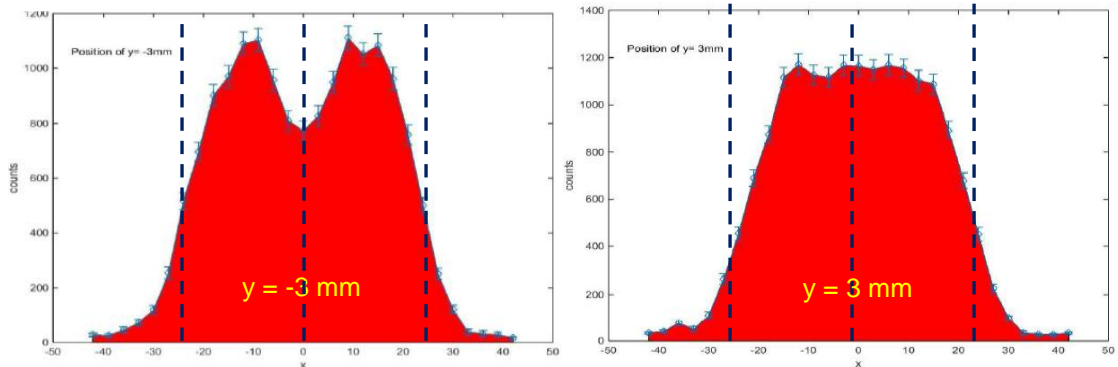
Fig. 3. Diagrams of counts a) vertical and b) horizontal scanning. The dashed lines indicate the nominal center and outer bounds of the crystal.

Diagrams of counts vs. X and Y positions were drawn as seen in Fig. 3. In the expected co-axial geometry, the different thickness of the Ge layer absorbing the emitted source photons would result in a non-uniform distribution of counts in X and Y scans.

An asymmetry in the Y axis is apparent in Fig. 3, near the edges of the graphs, that concerns the orientation of the crystal inside the cup. The edges have been used to estimate the internal and external diameter of the crystal. The data near the edges were initially fitted with a sigmoid function. Keeping in mind that the geometry of the crystal is coaxial, the internal diameter was estimated by measuring the distance between the mean values of the two curves that appear around the center. In analogy to that, the external diameter was estimated for the two curves at the edges. This procedure was repeated for both dimensions and the diameters were calculated.

Furthermore, a closer look at Fig. 3, considering the orientation of the crystal, suggests a slight tilt of the crystal inside the aluminum cup. Specifically, while comparing the two scans at the estimated center in both dimensions, the crystal appears to be symmetrical towards the x axis, whereas in the y axis there is a profound asymmetry. This is in agreement with the γ rays penetrating more material on the negative side of the y axis than on the positive, an observation that could only be explained by a tilt.

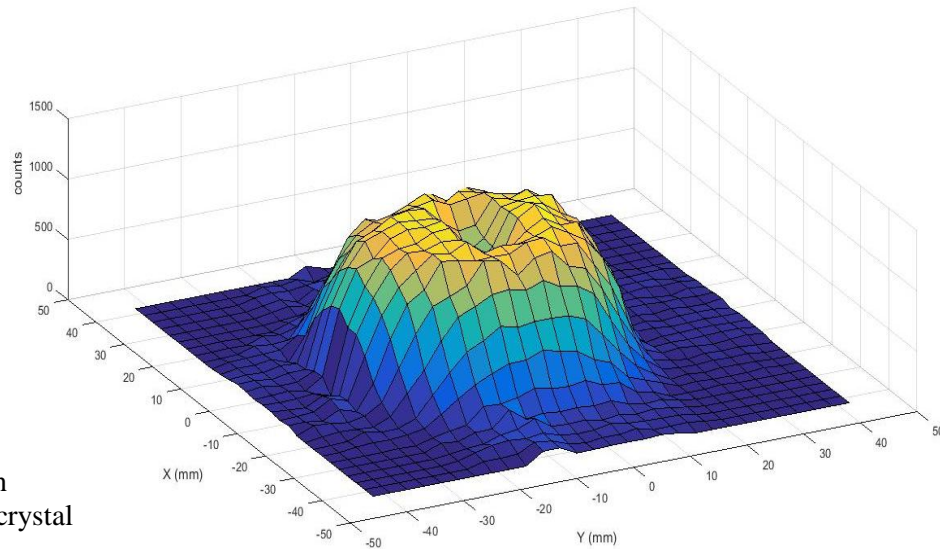
By combining all 2D diagrams, a 3D model of the crystal was reconstructed (Fig. 4). It is important to clarify that the 3D model does not show the actual shape of the crystal, but the absorbed energy of the γ -rays penetrating the crystal, throughout its whole volume. In essence, it is the reconstruction of the absorption coefficient 3D map, which is however inversely related to the geometry of the crystal.

Fig. 4. A 3D reconstruction model of the crystal

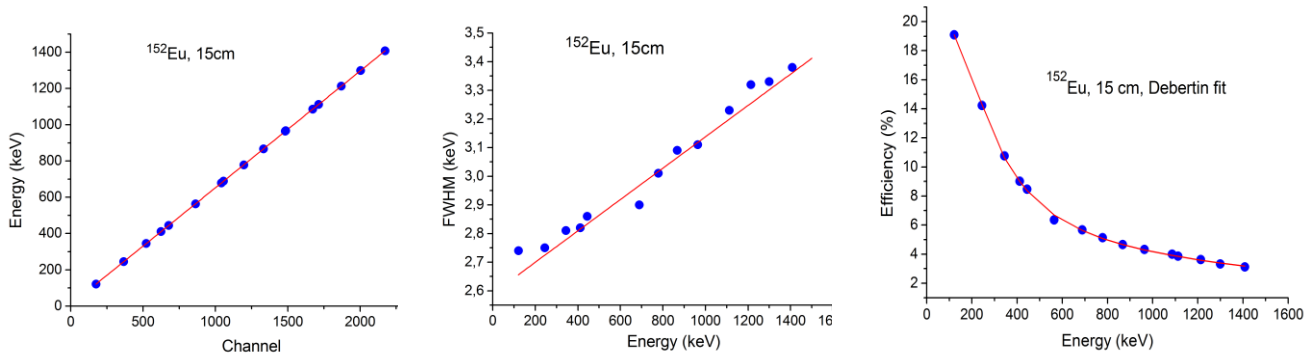
In Fig. 5 the linearity, energy resolution and absolute efficiency curves are depicted. The fit with a function $F(x)=Cx^2+Bx+A$ has produced the values $A=9.2$ keV, $B=0.6435$ keV/chn

and $C=9.2 \times 10^{-8} \text{ keV/chn}^2$. The excellent agreement between fit and data, as well as the tiny value of C , confirms the linearity of the detector.

Fig. 5. Linearity (left), energy resolution (middle) and absolute efficiency (right) curves deduced from a ^{152}Eu source placed at 15 cm from the detector's window and fitted with Debertin's equation

From the value of FWHM at 1332 keV, equal to 3.3 keV, a significant degradation of the resolution is evident when compared to the manufacturer's original value (2.06 keV). Despite this loss of resolution, attributed to the long inactivity, GEROS can still be used reliably for environmental studies. Moreover, the absolute efficiency curve is typical for a detector of its kind (in Fig. 5 a Debertin fit is shown) and is in the order of 3-5% for most of naturally occurring isotopes (^{238}U series, ^{40}K etc).

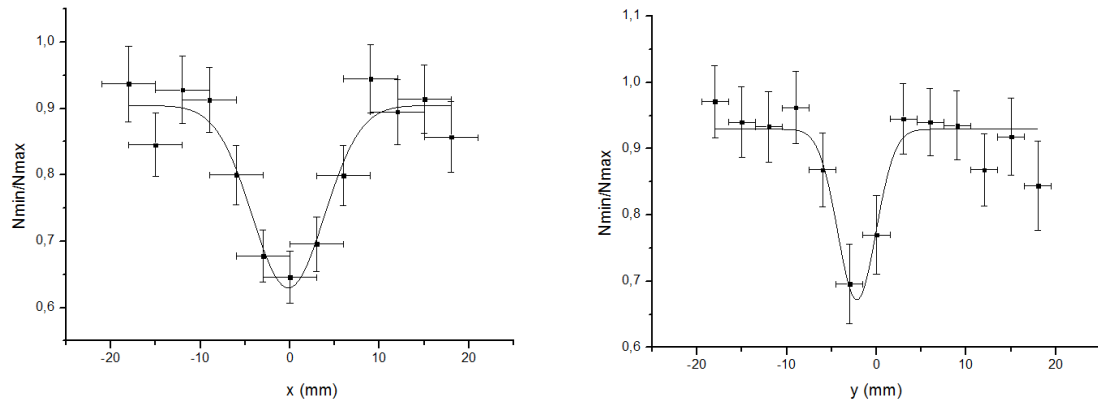
The exact position of the crystal's center was pursued in terms of finding the minima of the ratio N_{\min}/N_{\max} . Gaussian fits were performed on these ratios (Fig. 6) suggesting a minimum exists at (0,-2 mm), hinting a crystal displacement.

Fig. 6. Gaussian fits to locate the minima in X and Y scans.

With further study of the results, the center, the tilt and the dimensions of the crystal could be estimated in good detail. The center was determined by creating a plot of minimum to maximum recorded counts (N_{\min}/N_{\max}), around the area where the hole was expected, for each dimension of the X and Y axes. The data were fitted with a Gaussian function to determine the minimum point of the ratio, signifying the minimum position of the absorption coefficient, and thus the center of the crystal.

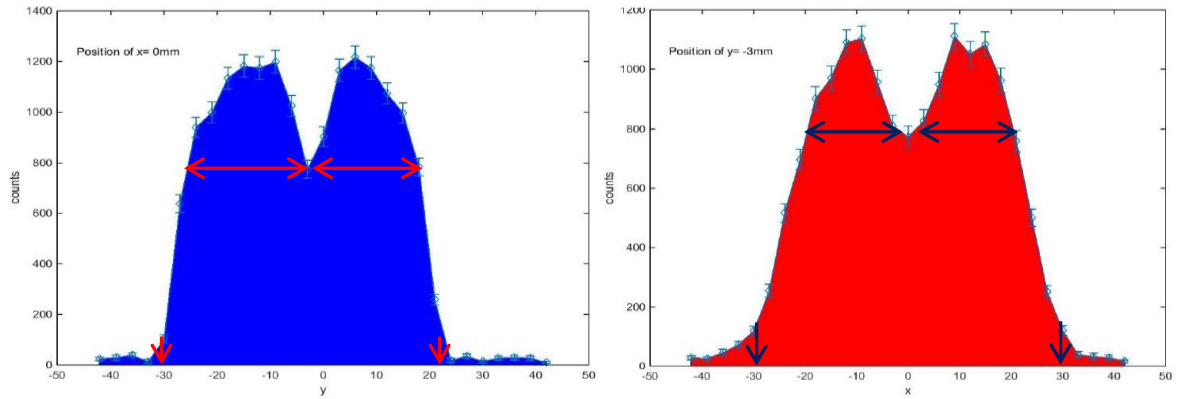
Fig. 7. Central scanings of vertical and horizontal dimensions of the crystal

Despite a difference existing between the values estimated for X and Y scans at first sight, the two values agree well within error. Consequently, the weighted average values were calculated as 9 and 47 mm for the internal and external diameter of the crystal, respectively.

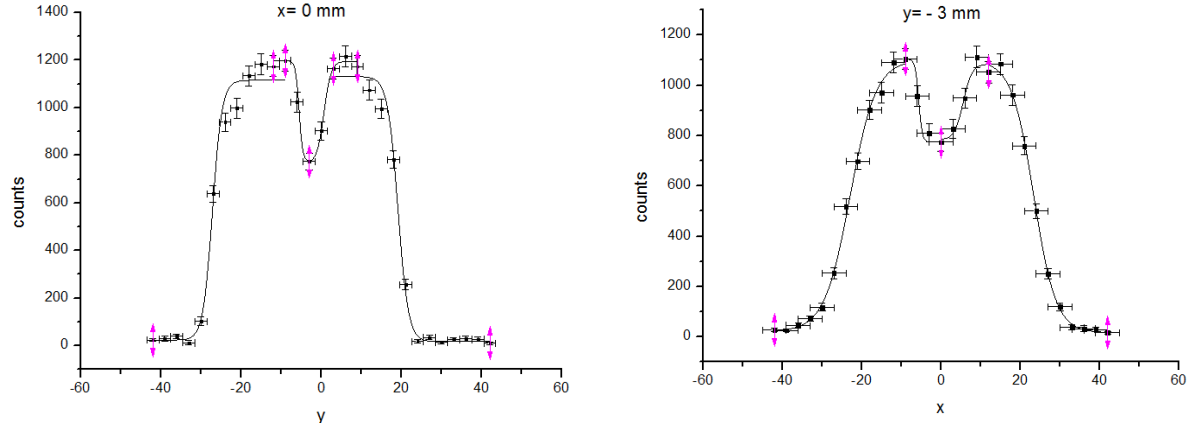
Fig. 8. Sigmoid fit of the central scans of the crystal

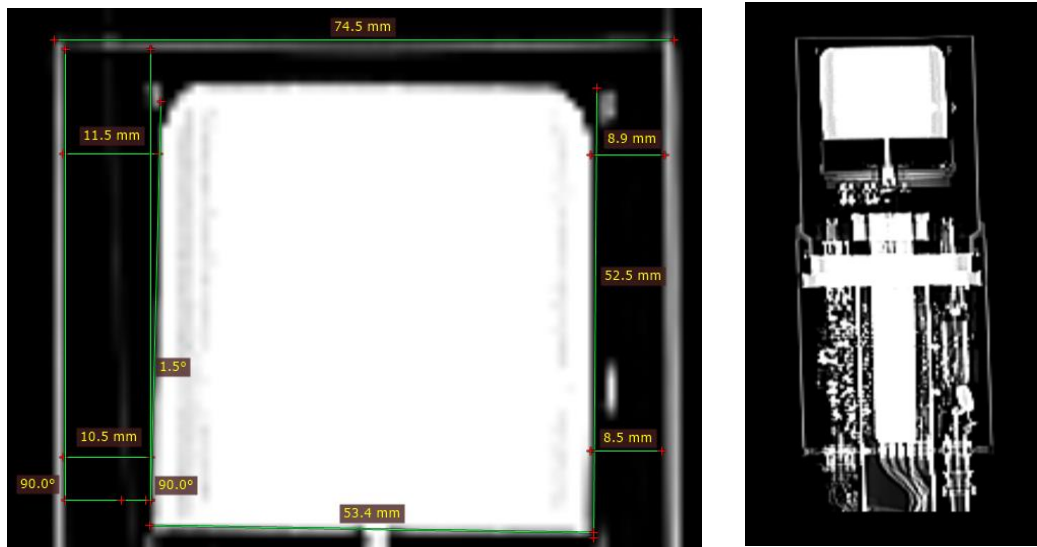
All results mentioned above, extracted by means of γ tomography were subsequently verified by 3D Computer-Aided Tomography (CT). Several slices of the detector were reconstructed producing pictures as the ones illustrated in Fig. 9. The discovered tilt of the crystal was found undoubtedly to exist (side view) inside the aluminum cup. The external diameter was measured at 53.4 mm, however it was impossible to see the hole on the inside, since the X-rays from the CT, even at the maximum available energy, are fully absorbed within some mm after entering the Ge ($Z=32$) crystal. It is worth noting that the diameter measured with the X-rays matches the nominal value on the text sheet. Comparing it with the 47 mm resulted from the γ -ray tomography, where only the active material can be measured, a difference of 4 mm appears. This points to a rather thick dead layer of 2 mm having formed around its surface due to its prolonged period of inactivity. An additional result of the CT scan is the measurement of the crystal length that could not be deduced by the γ -tomography measurements.

Fig. 9. Side (left) and full view (right) of the detector under X-rays in a medical CT scanner

To complete the investigation of the detector's internal structure and geometry, GEROS was placed in a medical CT scanner (X-ray Computed Tomography) in Lefkos Stavros Hospital. A complete tomography at various X-ray energies (40-120 keV) was performed and the study resulted in detailed determination of the crystal's outer dimensions and exact positioning.

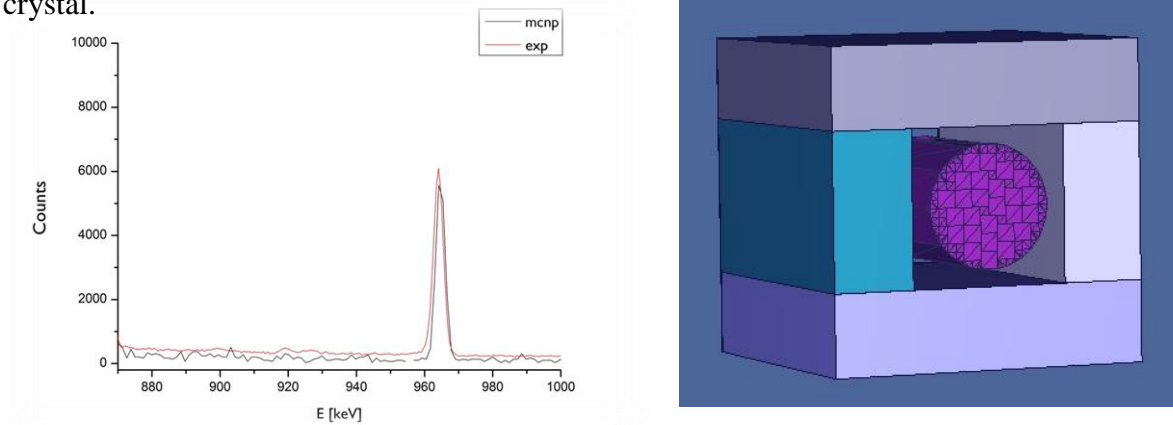
All extracted information on the geometry and the efficiency of the detector were used to carry out a Monte Carlo simulation using MCNP5 [4]. This work is still in progress, however preliminary results appear in good agreement with the experiment (Fig. 10). Additional simulations will focus on estimating the dead layer thickness and active volume of the Ge crystal.

Fig. 10. (Left) Experimental and MCNP-simulated spectra for a randomly selected ^{152}Eu peak (Right) The model geometry used in MCNP5 simulations
