Resurrected from the dead: Full characterization of an old HPGe detector using γ -ray and CT tomographies coupled to standard calibration techniques and simulations

Abstract A decommissioned co-axial HPGe detector has been recently acquired and returned to operational mode in an effort to build an environmental radiation spectrometer at the University of Athens. The new counting station, GEROS (Germanium for Environmental RadiOactivity Studies), was fully characterized prior to operation to obtain detailed information on its linear response, efficiency and energy resolution. In addition to using point-like calibration sources (^{60}Co , ^{137}Cs , ^{152}Eu and ^{226}Ra), several bulk sample geometries were calibrated by means of an IAEA standard, focusing on soils, sediments and solid materials.

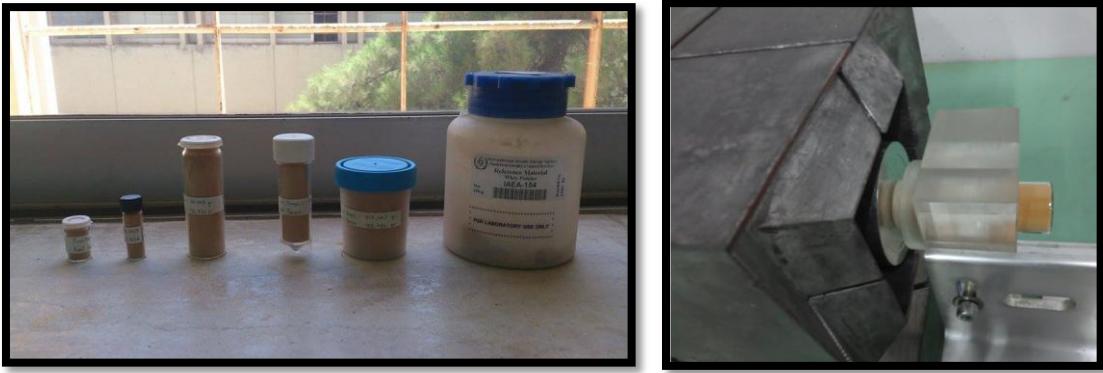
Fig. 1. The bulk samples and the IAEA reference material (left), and the set up (right)

In addition, as GEROS’ intended use is environmental radioactivity measurements, its efficiency was measured with five bulk samples of different cylindrical geometries, all containing quantities of an IAEA reference material (IAEA-154) of known specific activity. The low-activity samples were placed directly on the detector window (Fig. 1) mounted in a specially manufactured holder to maximize counting rates. From the measured counting rates of each sample (average measurement time 24 h), the conversion factors to actual specific activity have been determined.

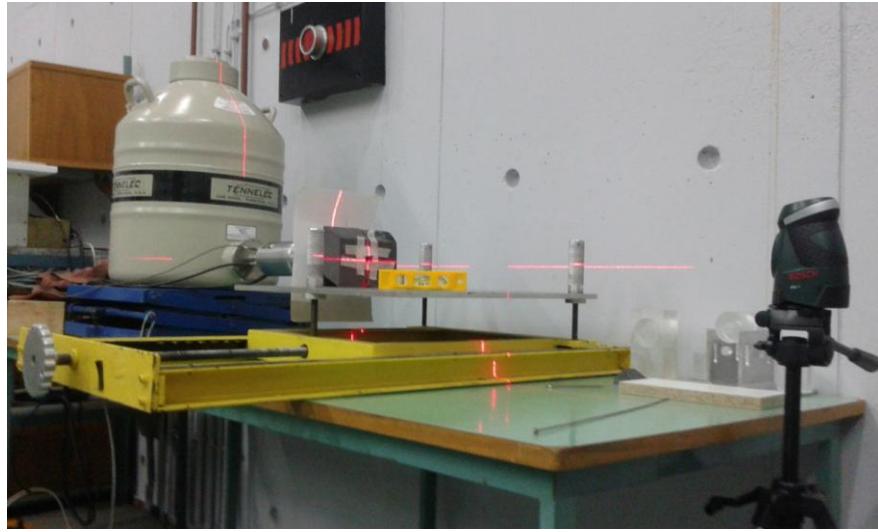
Fig. 2. The experimental set up for γ -ray tomography

For those measurements, a new set up was constructed. GEROS was placed on a X-Y motion platform. A custom collimator made out of four 5 cm x 5 cm Pb bricks was put together to shape a 3 mm x 3 mm hole, which was initially placed coaxially to the HPGe crystal with the help of an alignment laser (see Fig. 2). A weak ^{134}Cs source ($t_{1/2} = 2.0652$ y) was placed behind the hole of the collimator. On the window of the detector there was a predefined grid of positions, which was used to specify the coordinates of the collimated γ -rays spot. As the X-platform was manually moved to a new grid position, the γ -rays irradiated a different part of the crystal.

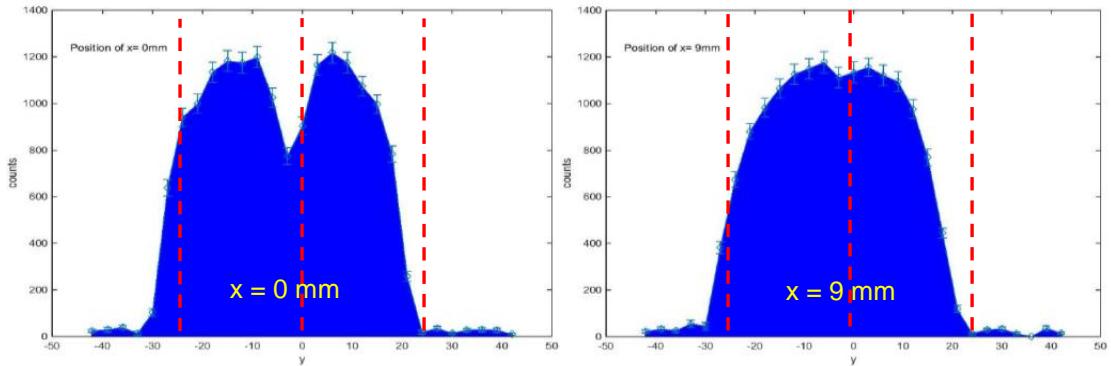
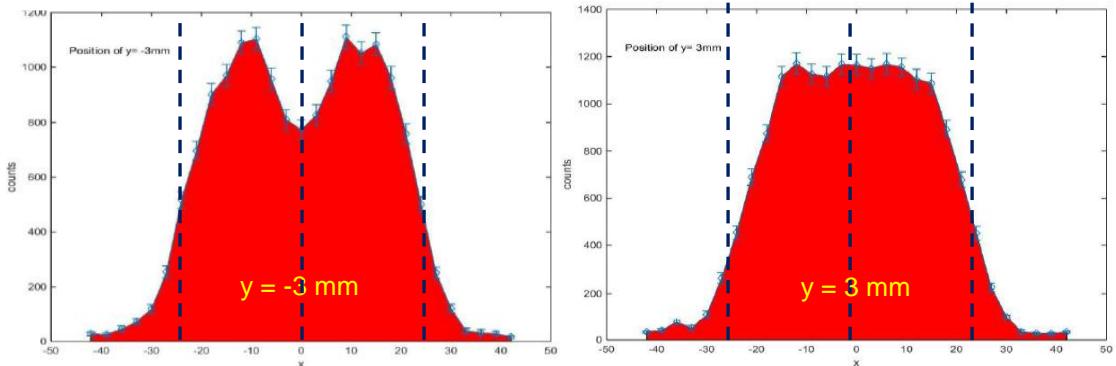
Fig. 3. Diagrams of counts a) vertical and b) horizontal scanning. The dashed lines indicate the nominal center and outer bounds of the crystal.

Diagrams of counts vs. X and Y positions were drawn as seen in Fig. 3. In the expected co-axial geometry, the different thickness of the Ge layer absorbing the emitted source photons would result in a non-uniform distribution of counts in X and Y scans.

An asymmetry in the Y axis is apparent in Fig. 3, near the edges of the graphs, that concerns the orientation of the crystal inside the cup. The edges have been used to estimate the internal and external diameter of the crystal. The data near the edges were initially fitted with a sigmoid function. Keeping in mind that the geometry of the crystal is coaxial, the internal diameter was estimated by measuring the distance between the mean values of the two curves that appear around the center. In analogy to that, the external diameter was estimated for the two curves at the edges. This procedure was repeated for both dimensions and the diameters were calculated.

Furthermore, a closer look at Fig. 3, considering the orientation of the crystal, suggests a slight tilt of the crystal inside the aluminum cup. Specifically, while comparing the two scans at the estimated center in both dimensions, the crystal appears to be symmetrical towards the x axis, whereas in the y axis there is a profound asymmetry. This is in agreement with the γ rays penetrating more material on the negative side of the y axis than on the positive, an observation that could only be explained by a tilt.

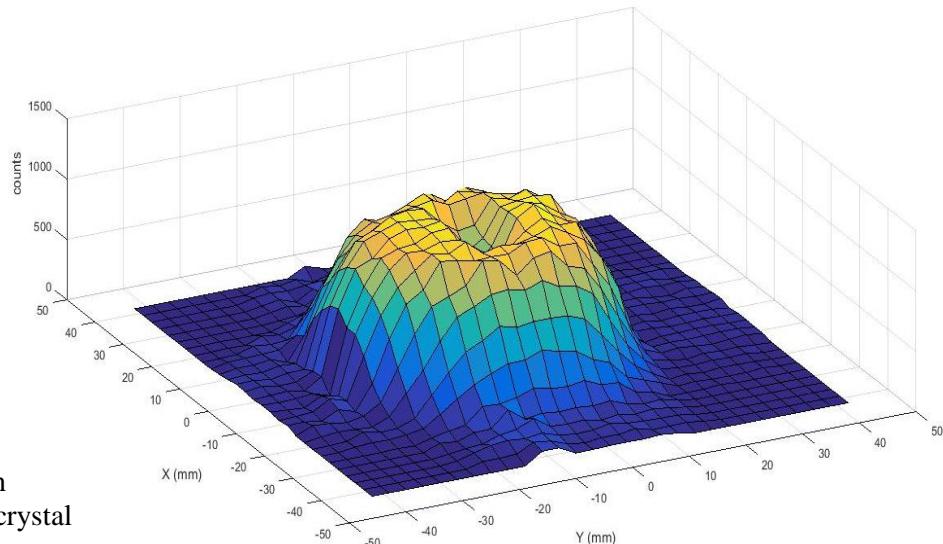
Fig. 4. A 3D reconstruction model of the crystal

By combining all 2D diagrams, a 3D model of the crystal was reconstructed (Fig. 4). It is important to clarify that the 3D model does not show the actual shape of the crystal, but the absorbed energy of the γ -rays penetrating the crystal, throughout its whole volume. In essence, it is the reconstruction of the absorption coefficient 3D map, which is however inversely related to the geometry of the crystal.

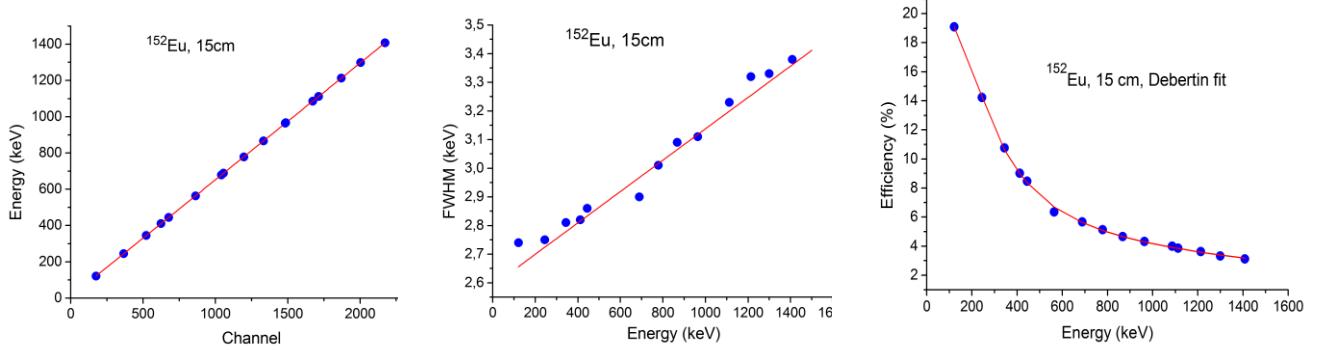
Fig. 5. Linearity (left), energy resolution (middle) and absolute efficiency (right) curves deduced from a ^{152}Eu source placed at 15 cm from the detector's window and fitted with Debertin's equation

In Fig. 5 the linearity, energy resolution and absolute efficiency curves are depicted. The fit with a function $F(x)=Cx^2+Bx+A$ has produced the values $A=9.2$ keV, $B=0.6435$ keV/chn

and $C=9.2 \times 10^{-8}$ keV/chn². The excellent agreement between fit and data, as well as the tiny value of C, confirms the linearity of the detector.

From the value of FWHM at 1332 keV, equal to 3.3 keV, a significant degradation of the resolution is evident when compared to the manufacturer's original value (2.06 keV). Despite this loss of resolution, attributed to the long inactivity, GEROS can still be used reliably for environmental studies. Moreover, the absolute efficiency curve is typical for a detector of its kind (in Fig. 5 a Debertin fit is shown) and is in the order of 3-5% for most of naturally occurring isotopes (^{238}U series, ^{40}K etc).

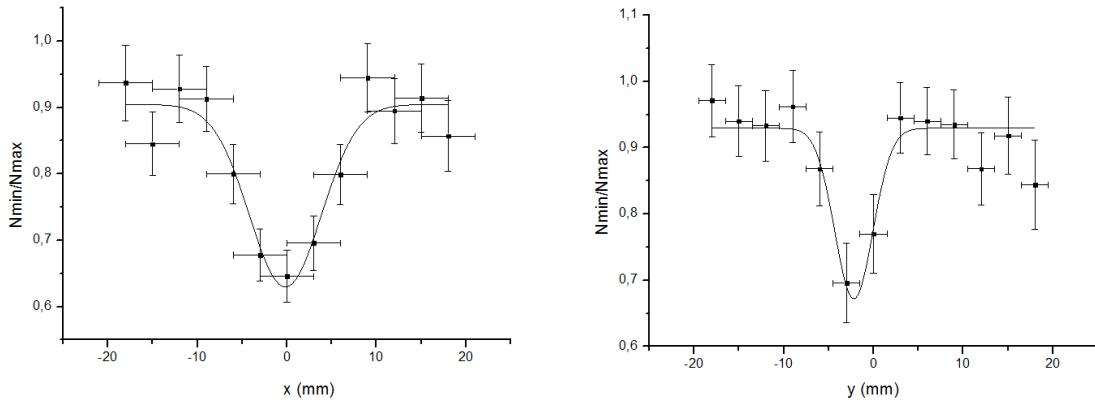
Fig. 6. Gaussian fits to locate the mimima in X and Y scans.

The exact position of the crystal's center was pursued in terms of finding the minima of the ratio N_{\min}/N_{\max} . Gaussian fits were performed on these ratios (Fig. 6) suggesting a minimum exists at (0,-2 mm), hinting a crystal displacement.

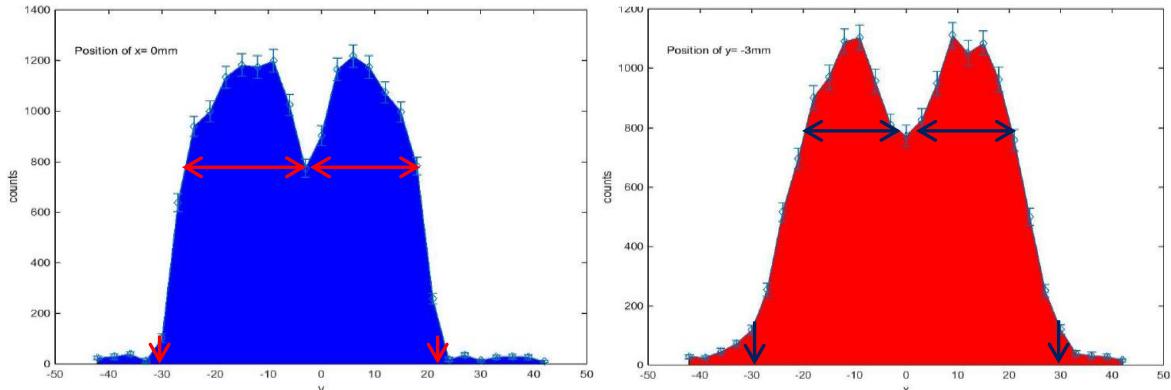
Fig. 7. Central scanings of vertical and horizontal dimensions of the crystal

An important structural detail in the co-axial type is the existence of an internal hole in the cylindrical shape of Ge (resembling a “II” shape in side view). The size of this inner (missing) cylinder was not known beforehand. However it is important information as it affects the total active volume of the detector. In Fig. 8, sigmoidal curves were used to determine the radius of the inner cylinder, but also the outer (active) diameter of the crystal. It is important to note that the latter result excludes the dead layer of the crystal. The results are summarized in Table 2.

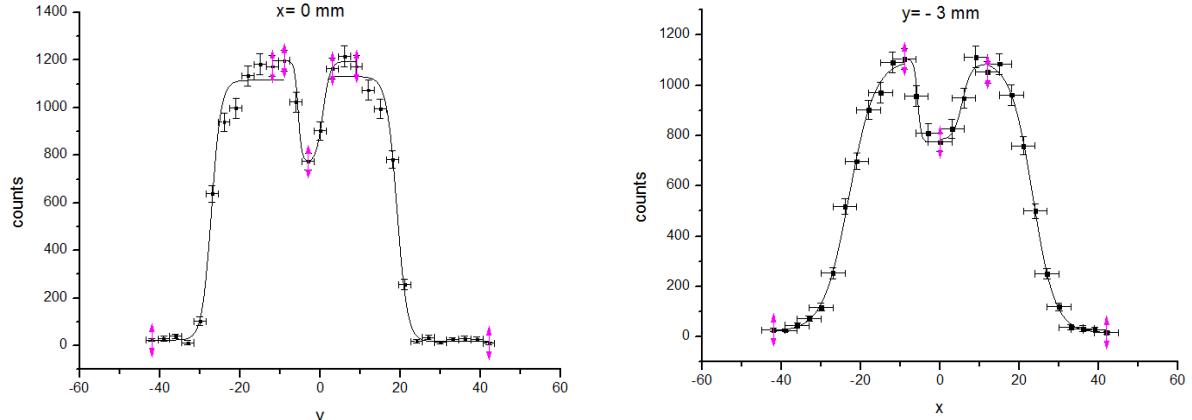
Fig. 8. Sigmoid fit of the central scans of the crystal

Despite a difference existing between the values estimated for X and Y scans at first sight, the two values agree well within error. Consequently, the weighted average values were calculated as 9 and 47 mm for the internal and external diameter of the crystal, respectively.

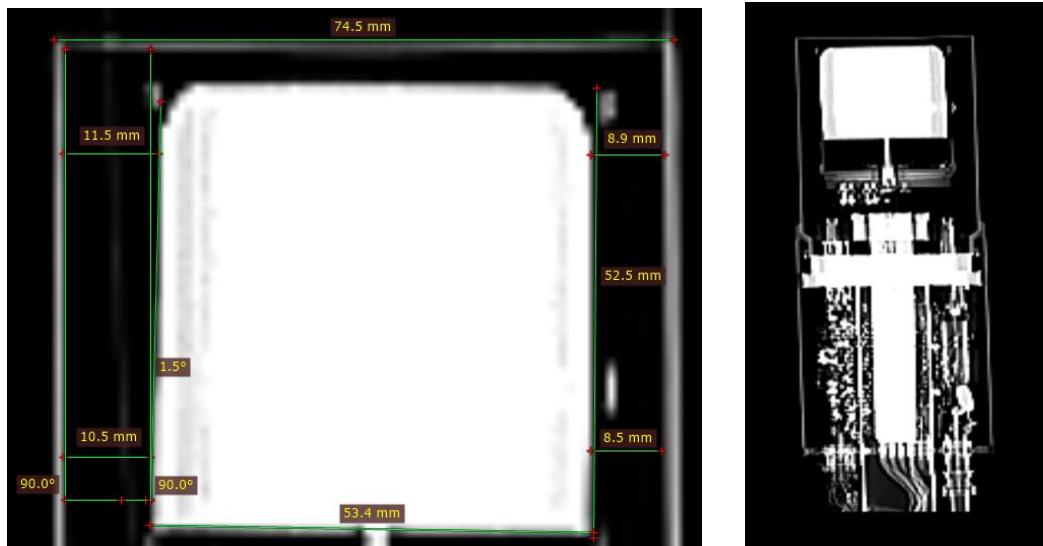
Fig. 9. Side (left) and full view (right) of the detector under X-rays in a medical CT scanner

All results mentioned above, extracted by means of γ tomography were subsequently verified by 3D Computer-Aided Tomography (CT). Several slices of the detector were reconstructed producing pictures as the ones illustrated in Fig. 9. The discovered tilt of the crystal was found undoubtedly to exist (side view) inside the aluminum cup. The external diameter was measured at 53.4 mm, however it was impossible to see the hole on the inside, since the X-rays from the CT, even at the maximum available energy, are fully absorbed within some mm after entering the Ge ($Z=32$) crystal. It is worth noting that the diameter measured with the X-rays matches the nominal value on the text sheet. Comparing it with the 47 mm resulted from the γ -ray tomography, where only the active material can be measured, a difference of 4 mm appears. This points to a rather thick dead layer of 2 mm having formed around its surface due to its prolonged period of inactivity. An additional result of the CT scan is the measurement of the crystal length that could not be deduced by the γ -tomography measurements.

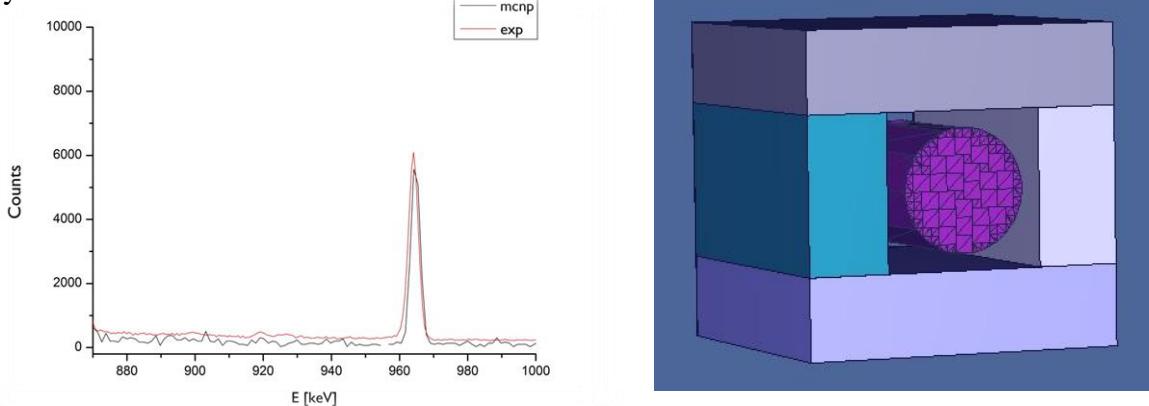
Fig. 10. (Left) Experimental and MCNP-simulated spectra for a randomly selected ^{152}Eu peak (Right) The model geometry used in MCNP5 simulations

All extracted information on the geometry and the efficiency of the detector were used to carry out a Monte Carlo simulation using MCNP5 [4]. This work is still in progress, however preliminary results appear in good agreement with the experiment (Fig. 10). Additional simulations will focus on estimating the dead layer thickness and active volume of the Ge crystal.
